Best of Series

Building with Steel

The Mark

Common Problems in Steel Deck and Joist Design

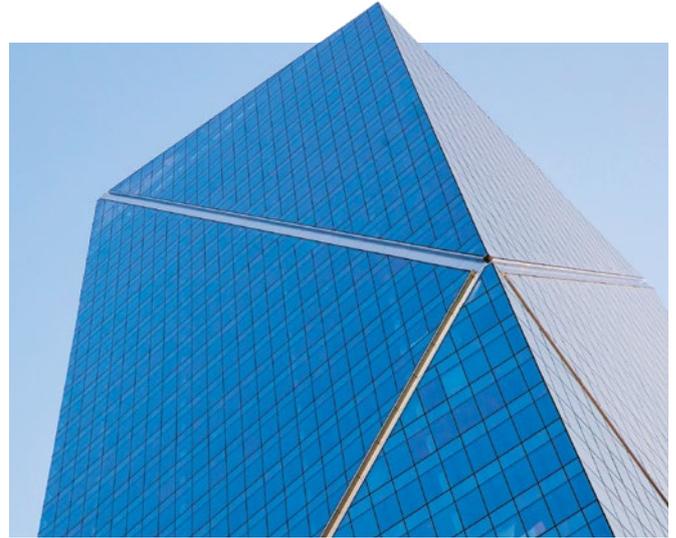
The faceted scheme, with fewer lateral elements configured at open angles, eliminates view-obstructing components like columns and has created more floor-plate efficiency by reducing the building's core size.

In looking at various frame configurations, the most architecturally satisfying solution was to cross each face of the building with three major diagonal brace elements meeting at key corner points.

These 'megabraces' form the edges of jewel-like facets, with planes angled to create an expanding floor plate over the building height. Most of the exterior columns are canted up to six degrees to support the floor plates, which increase in size through the 18th floor and then vary in shape on the higher levels. Diagonal lines meet at corner points on levels 16 and 28—the latter has the largest floor plate. In order for forces to be transferred between the megrabraces and floor diaphragms, the braces meet the floor at the same point, above and below brace intersections where a column or another brace meets the floor (select levels only), to smoothly move loads to the ground.

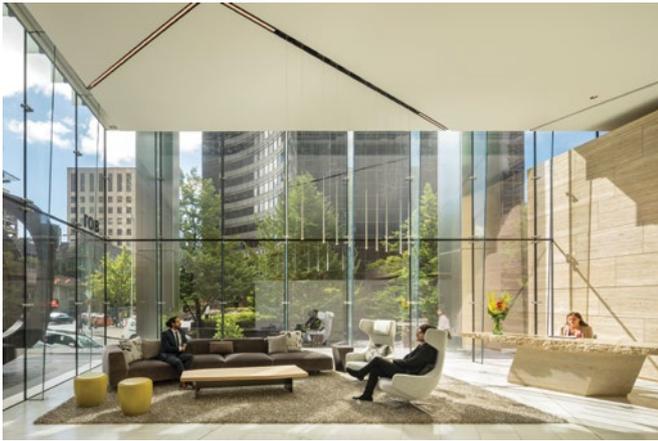
The lobby of the Mark emphasizes daylight and transparency.

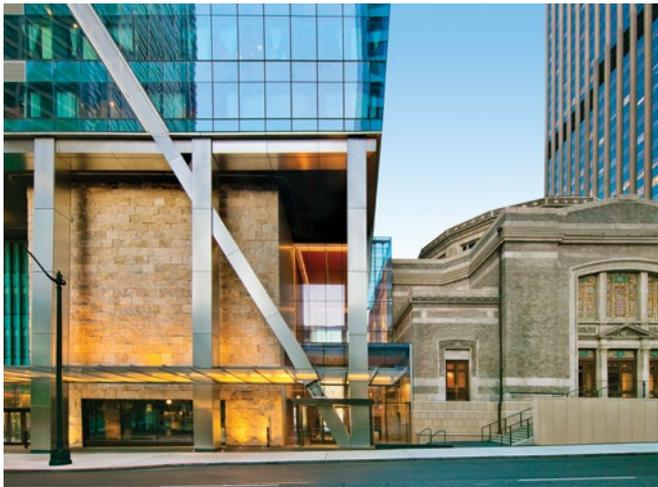
To preserve the former First United Methodist Church, built in the early 20th century, ZGF Architects designed a tower that cantilevers over it instead of taking its place. Last year, the church building made its reintroduction as the Sanctuary, a space for events and meetings in Seattle.

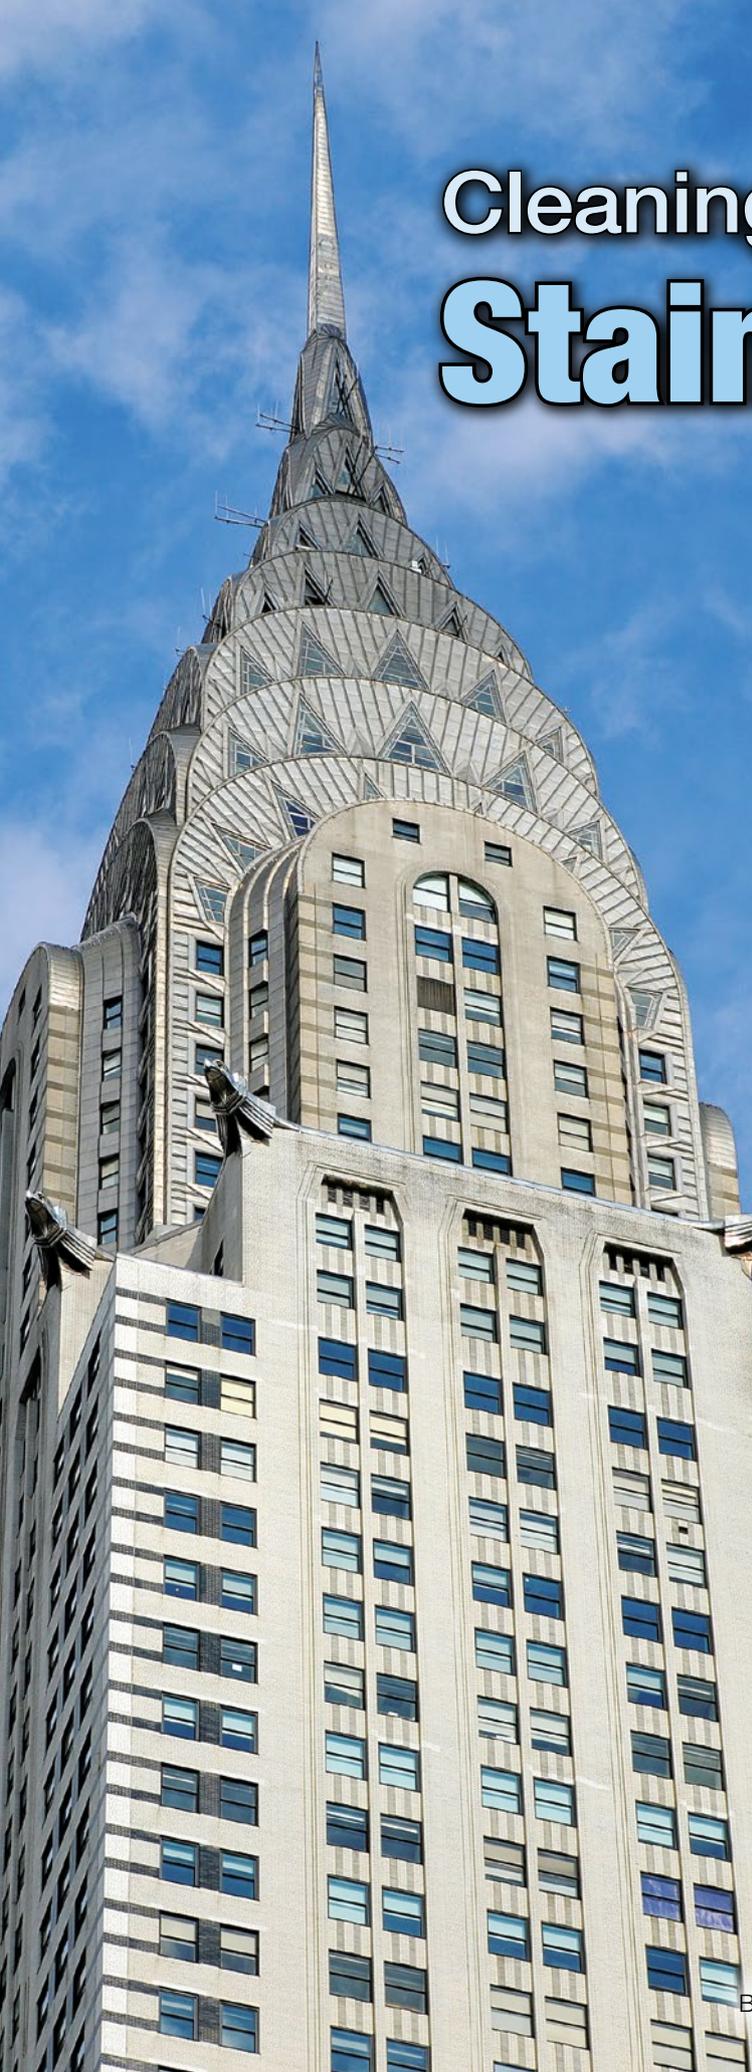
Cleaning and Maintaining Stainless Steel

WITH APPROPRIATE SPECIFICATION, STAINLESS STEEL CAN LAST THE LIFE OF A BUILDING.

Since its invention over a century ago, stainless steel's durable beauty has been repeatedly demonstrated. In the mid-1990s, more than 30 years of dirt, hydrocarbons, and other deposits had blackened the iconic upper floors of New York's Chrysler (left) and Empire State buildings, but simple cleaning with products commonly found in household kitchens returned them to their original appearance (Figure 1).

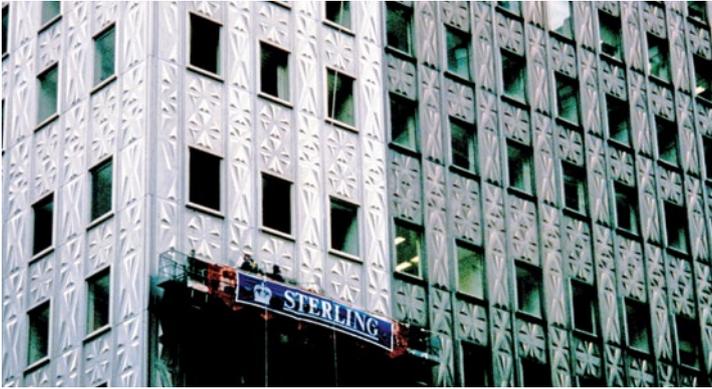
Figure 1

In 1995, the exterior of New York's 150 East 42nd Street (former Socony Mobil Building) was cleaned for the first time in 40 years, removing dirt and hydrocarbon accumulations.

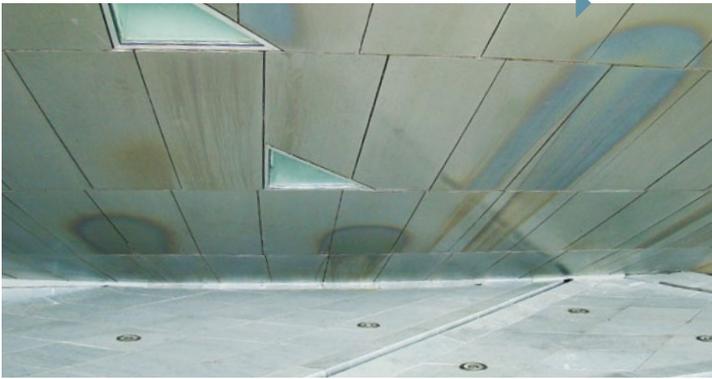
Figure 2

This Chinese museum has a fountain along one side, which sprays water on to the surface. The water's high total dissolved solids (TDS) content is causing staining on both the stainless steel panels and the stone. While this staining can be removed, avoiding the problem by installing a reverse-osmosis (RO) system is best.

Suitable water may need to be purchased or a reverse-osmosis (RO) system installed. It is important never to use natural untreated, industrial, or swimming pool water. When acidic cleaning products are used, the rinse water should have a maximum TDS content of 200 ppm or be de-ionized, distilled, or RO water—otherwise, hard water staining occurs (Figure 2). While it can be removed, opting for avoidance is far more cost-effective.

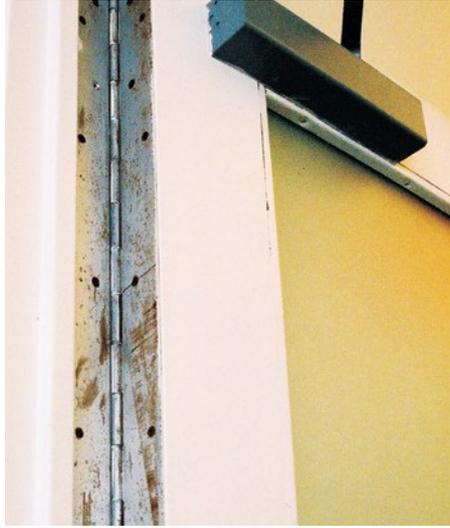
A maintenance worker ‘cleaned’ the hinges in this natatorium room with a household carbon steel wool pad. The corrosion is from the resultant embedded iron particles.

- metal scrapers, brushes, or wool pads;
- coarse abrasive powders; and
- abrasive blast media. (See Figure 3 for an example.)

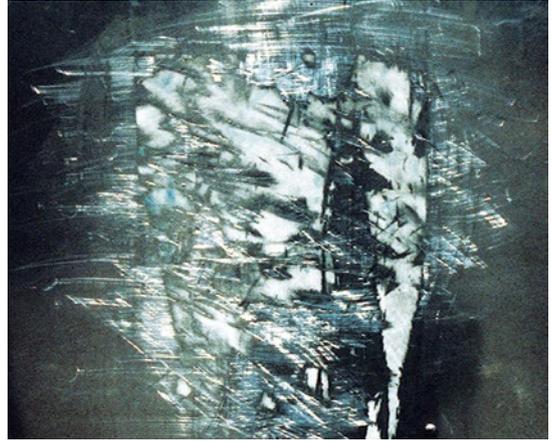
Figure 4

This stainless steel surface has been badly damaged by a maintenance worker’s attempt to remove a poster with a metal scraper instead of an appropriate solvent.

A soft nylon brush or plastic scraper can be used to help loosen adherent surface deposits, but should be tested first to ensure against surface damage. When cleaning directional finishes, one should always rub along the grain (Figure 4).

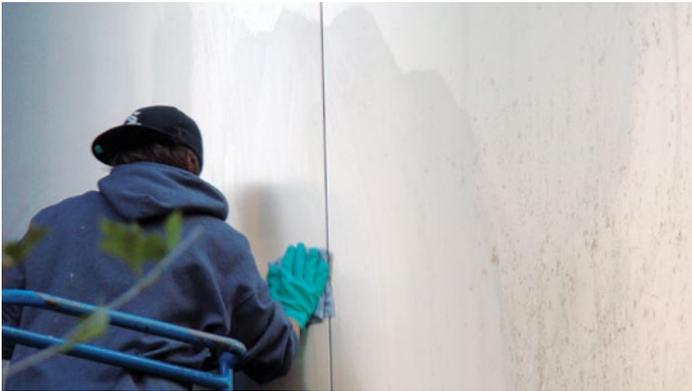
Figure 5

Dirt and grime are easily removed with simple cleaning of the stainless steel.

This makes it easy to clean adjoining stainless steel surfaces as windows are cleaned. These products are also suitable for other light cleaning requirements, but they will not remove heavier fingerprinting (Figure 5).

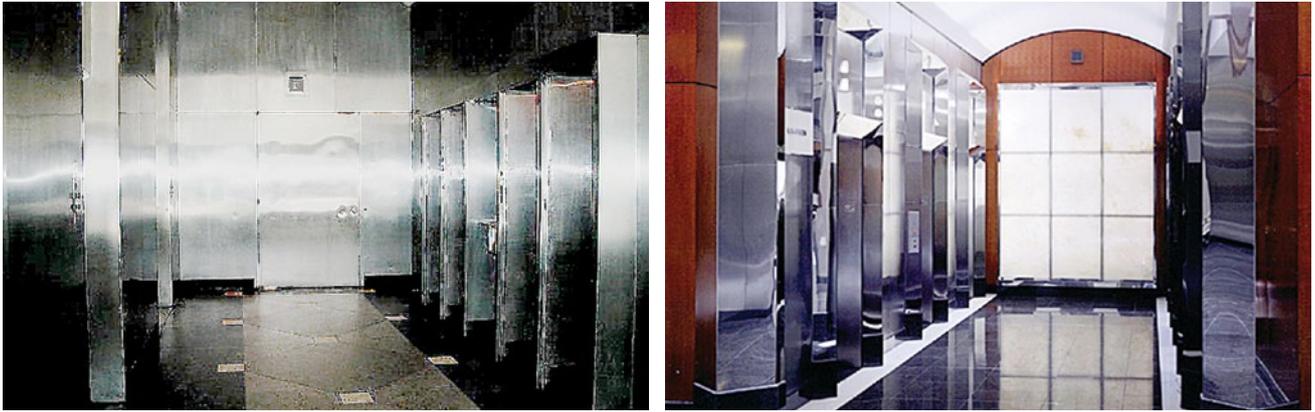
Figure 6

After 50 years of oil and wax ‘cleaning,’ the stainless steel in this lobby was dark from dirt and grime accumulation and had some scratching (left). The panels were taken down, cleaned with dishwashing detergent, refinished with non-metallic abrasive pads, reshaped, and reused in the new design (right). Any unused metal was recycled after the reshaping.

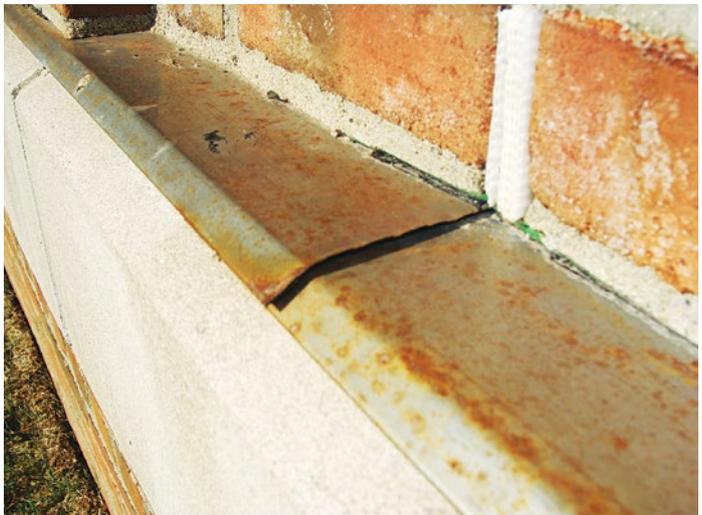
Figure 7

Muriatic (*i.e.* hydrochloric) acid was used to clean the masonry, causing corrosion of the drip edge. Similar damage has been observed by this author on kitchen cabinets after interior tile cleaning and on exterior railings and doors after concrete cleaning.

Hydrochloric acid (*i.e.* muriatic acid) is very corrosive to construction materials; it should never be used for cleaning tile, concrete, or masonry near stainless steel. Concentrations of as little as 0.1 percent can cause room temperature corrosion of Type 304/304L (UNS S30400/S30403).

and the acid should be neutralized (Figure 7). Alternative cleaning products are available.

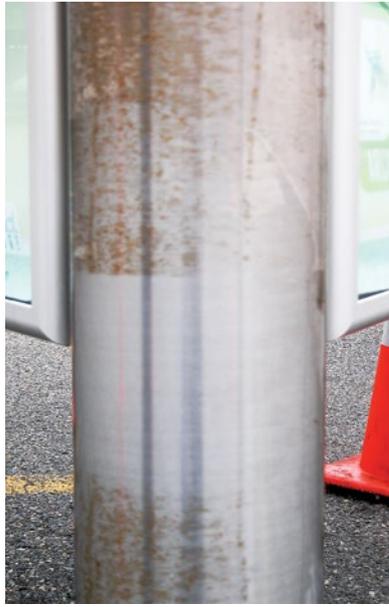
Figure 8

This pipe supports a beach park canopy. Unfortunately, the supplier did not use an ultraviolet (UV)-rated strippable film, and the pipe was exposed to the sun for several days prior to removal. The areas with residual adhesive accumulated far more coastal salt than surrounding surfaces, causing light surface corrosion. It was removed with fine abrasive paste suitable for cleaning glass and is now performing well. The test area is shown.

When recently applied, some can be removed with an eraser, mild detergent, vinegar (or ammonia), and water mixture. Plastic bristle brushes and scrapers may assist in removal, but anything that could scratch the surface should be avoided. Non-toxic household adhesive removers are also often very effective. If the finish is not mirror-polished or colored, fine abrasive cleaners suitable for glass can be made into a paste and then gently rubbed on with the grain to assist in removal. A strong solvent may be required, but it should be tested on a small area in advance and washed off completely afterward (Figure 8).

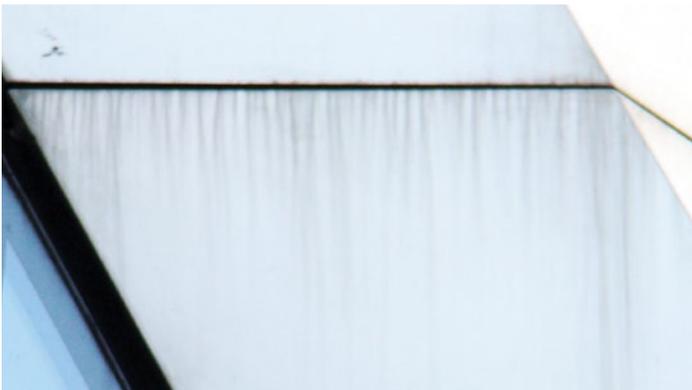
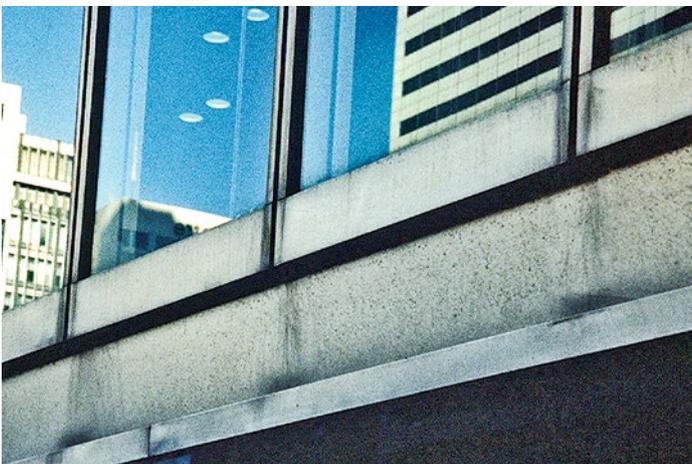
Figure 9

As shown above, fairly consistent dark areas or streaks below a joint are indicative of sealant deterioration and the accumulation of atmospheric particulate on the tacky surface. The stainless steel panels below are very dirty. Rainwater flow patterns or channeling is creating dirt and hydrocarbon streaking in selected areas. This can be corrected with standard cleaning procedures.

‘Rundown’ occurs when fluids are released from sealant, producing dark areas or streaks below the joints as dirt, hydrocarbons, and other substances in the air collect on the tacky surface. The causes can range from poor installation to chemical exposure to normal end-of-service-life deterioration.²

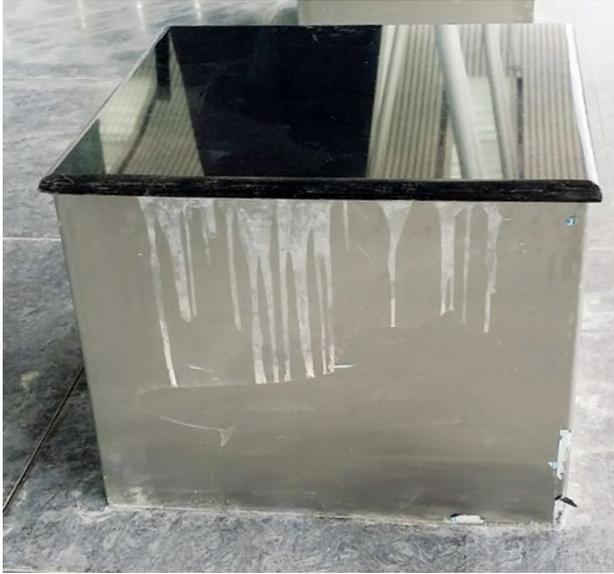
Figure 10

Outside an Indian airport, concrete spilled off the sides of these bollards when they were filled. Unfortunately, it was not washed off immediately. Power-washing may be effective in removing the deposit.

If cement or mortar is accidentally spilled onto stainless steel, it should be washed off immediately with adequate water before it can set. Otherwise, removing solidified material can be difficult without causing surface damage. If the surface is smooth, it may fall off as it dries. Low-power-washing can also be tried, with the water stream angled to loosen the deposit edge.

If the cement or mortar has been allowed to dry on the surface, dark multi-color alkaline staining may be apparent on the stainless steel surface after the deposit is removed. This can be removed by rubbing a paste of fine abrasive powders and water on the surface. However, if the stainless steel

surface is colored or coated with metal, permanent surface damage may occur (Figure 10).
