SEALING THE BUILDING ENVELOPE

WRB-AB Sheathing Streamlines Wall Assembly and Cladding Compatibility

What is Happening Behind Stucco and Manufactured Stone?

Keeping Low-slope Roofs Dry in **Northern Climates**

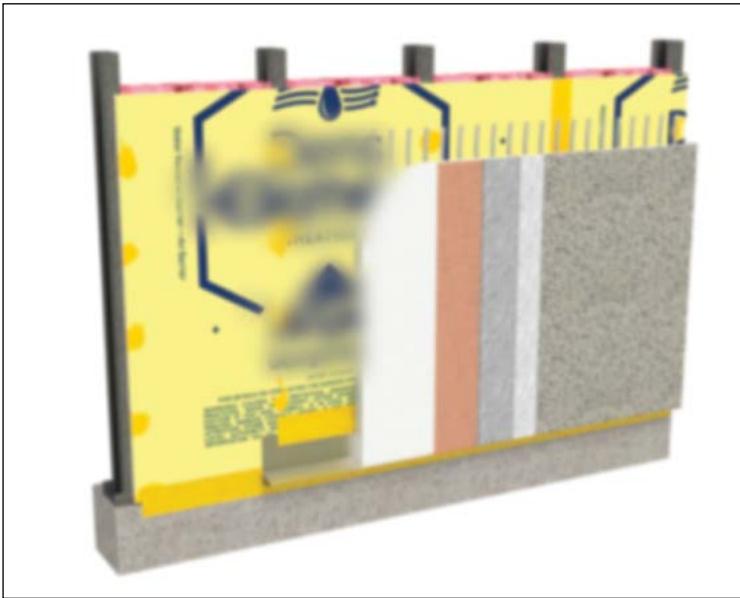
The gypsum-integrated water-resistant barrier-air barrier (WRB-AB) assembly streamlines the entire construction process when different cladding selections are specified.

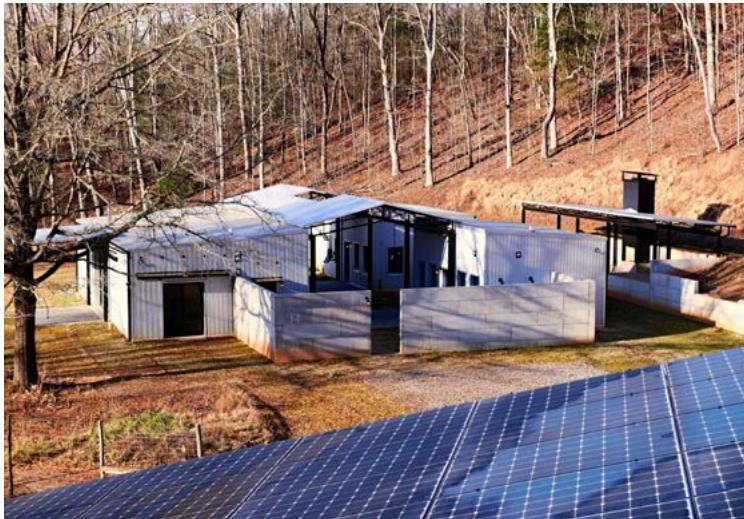
The installation of a gypsum-integrated WRB-AB sheathing and a liquid flashing approved for damp conditions created an airtight building enclosure at Benoit Farms, North Carolina.

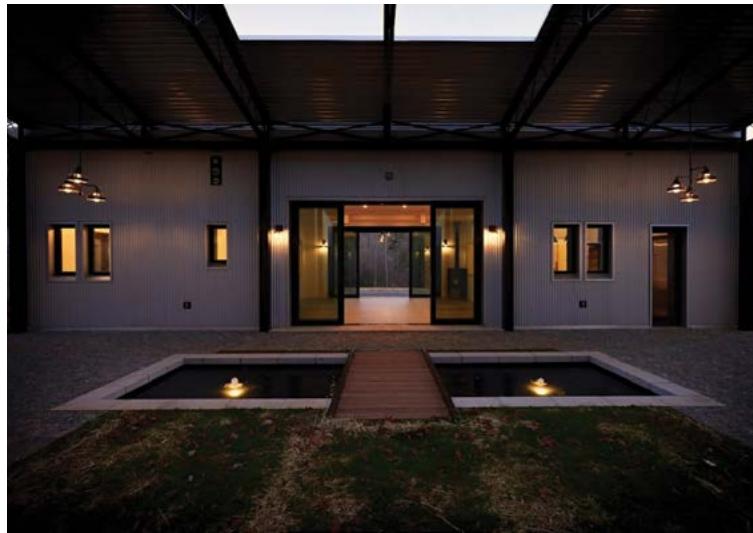
Architecture firm LG Squared attached integrated gypsum sheathing to the cladding of the Benoit Farms building to provide a continuous WRB-AB layer and protect the facility and its occupants from potential fires.

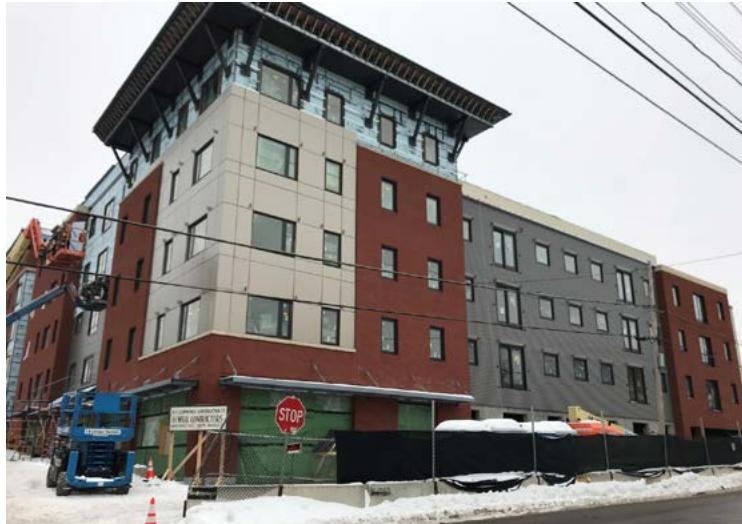
Integrated gypsum sheathing has been installed on Eagle's Landing Apartments in Burlington, Virginia.

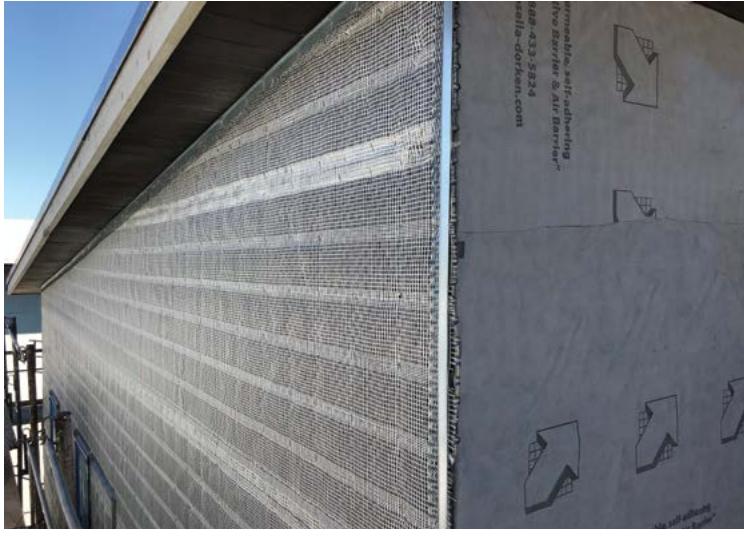
Located in front of a spun-bonded polypropylene, self-adhering air- and water-resistive barrier, the rainscreen system featured a drainage and ventilation layer in one, but also incorporates the lath for the first scratch coat of the stucco.

To create a high-performance wall system, a two-in-one rainscreen and lath was selected. Located in front of a spun-bonded polypropylene, self-adhering air- and water-resistive barrier, the rainscreen system features a drainage and ventilation layer in one, but also incorporates lath for the first scratch coat of the stucco. Simplifying many steps, the ventilated rainscreen with pre-installed glass lath will help to eliminate the building enclosure's risk of solar-driven moisture. At the same time, this one-step moisture control and lath system would allow any incidental moisture from within the wall to dry to the outside.

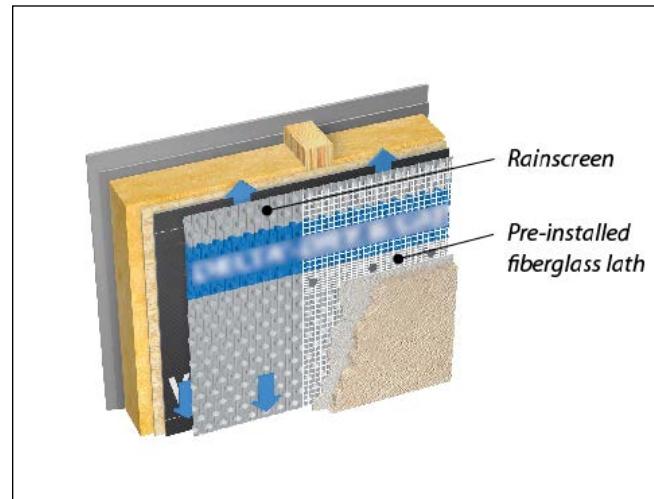
Illustration of stucco installed over a rainscreen with pre-installed fiberglass lath.

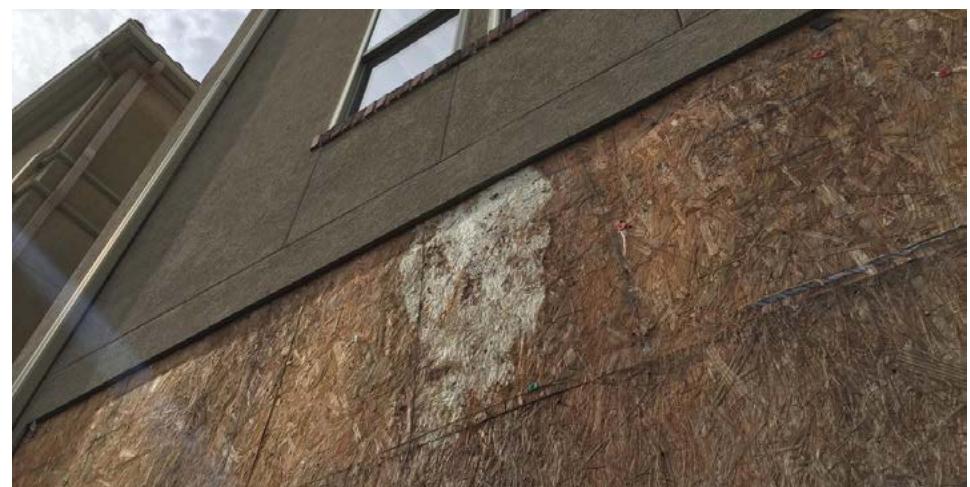
Moisture damage on wood-frame, low-rise building.

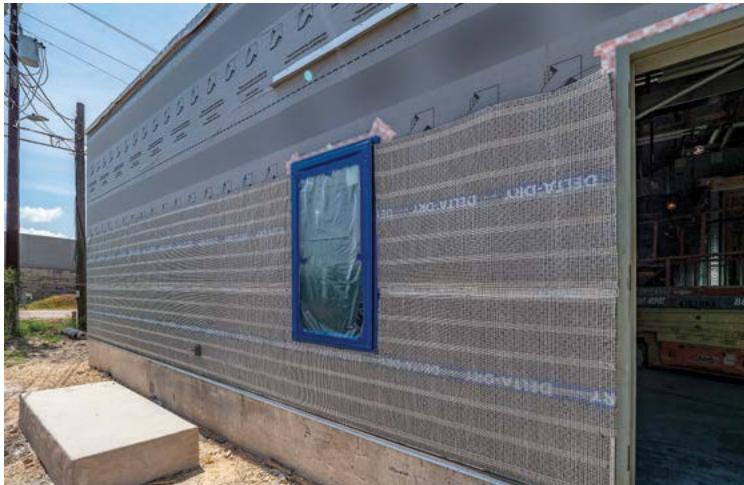
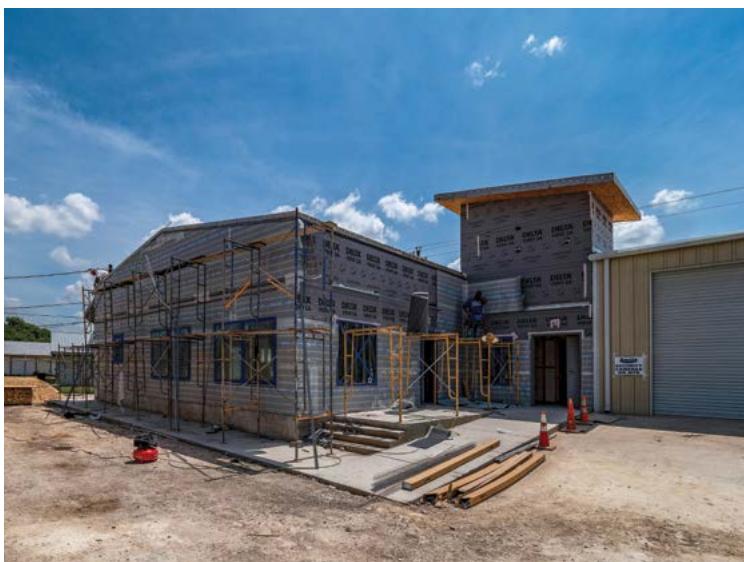
Ventilated rainscreen membrane that is made of a special high-density polyethylene (HDPE) with pre-installed glass lath.

There are products incorporating all these qualities. For example, ventilated rainscreen membranes made of a special high-density polyethylene (HDPE) with pre-installed glass lath are multifunctional and provide high levels of moisture permeability along with the all-important water- and air-tightness.

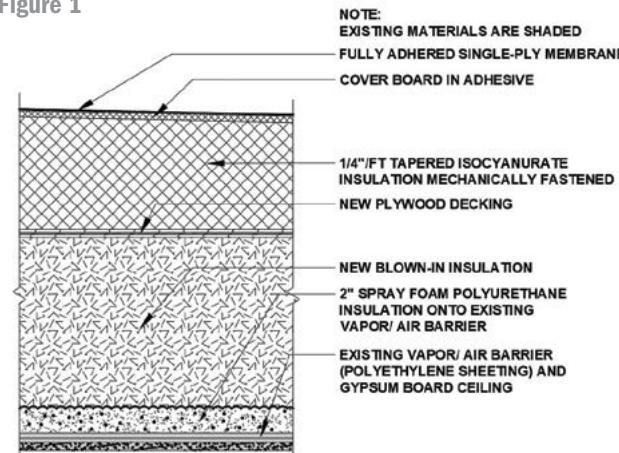
► Figure 1

The first repair option for the roof of the Coborn Plaza Apartments in Minnesota.

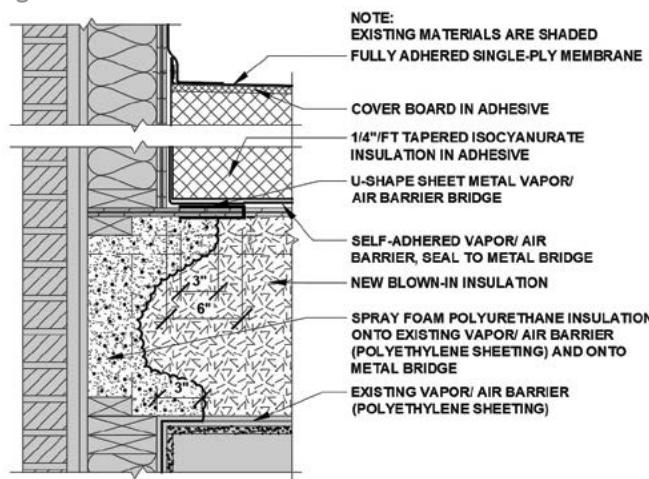
► Figure 2

The second repair option.

The second option required removal of the existing system down to the structural roof deck and the replacement of any wet, rotted, and/or moldy deck and blown-in insulation (Figure 2, page 17). A roof vapor/air barrier would be applied on the structural roof deck.

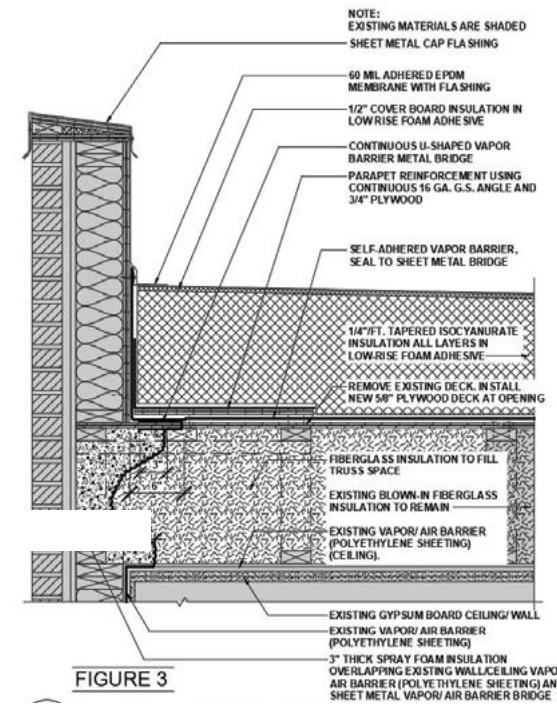
FIGURE 3

Tall parapet at nonbearing roof truss.

The second option was selected and developed into construction documents for bidding and construction (Figure 3, page 18). This was the best solution to achieve the goal of a complete vapor/air barrier. It also exposed the existing assembly to allow for the removal and remediation of wet, deteriorated, and moldy roof components. This option also maximized the reuse of the structural roof deck and blown-in insulation that was still in acceptable condition.

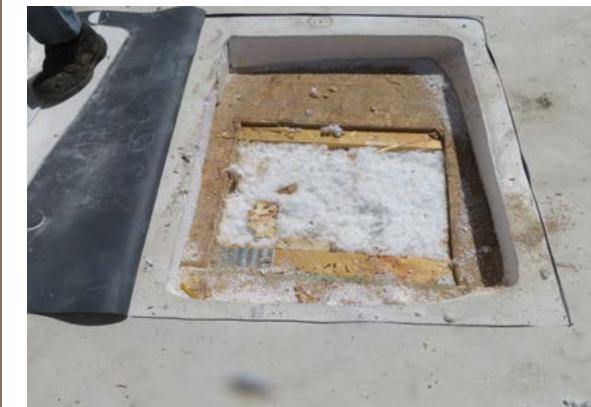
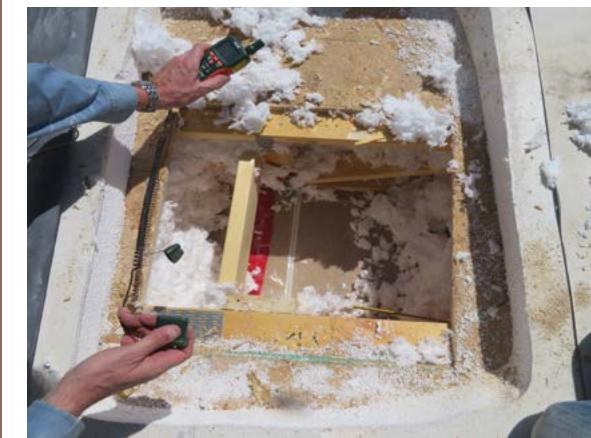
► Figure 4

Typical invasive inspection opening above trusses (top) and below roof deck sheathing (bottom).

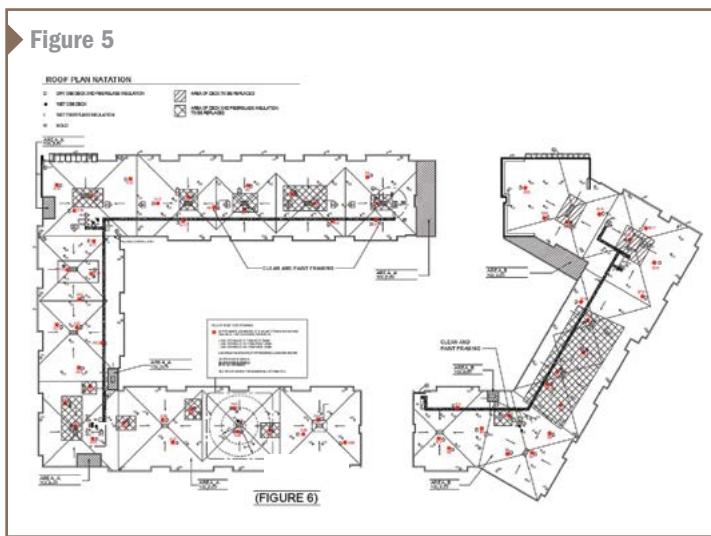
Approximate areas of roof deck and insulation replacement.

Based on the 60 invasive inspection openings, test results, and observations, a roof plan was developed showing the approximate areas where roof deck sheathing and blown-in insulation would most likely require replacement (Figure 5, page 19). The final determination of what needed replacement would be made by the contractor when each area was opened daily. While onsite performing their periodic observations,

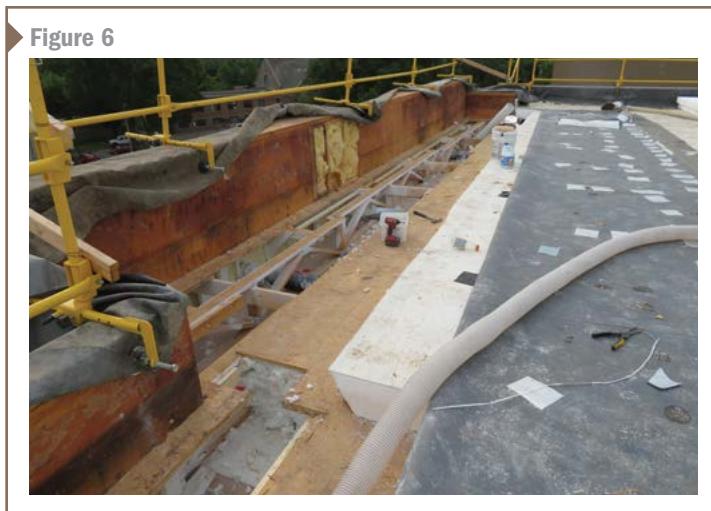
Typical work at roof perimeter.

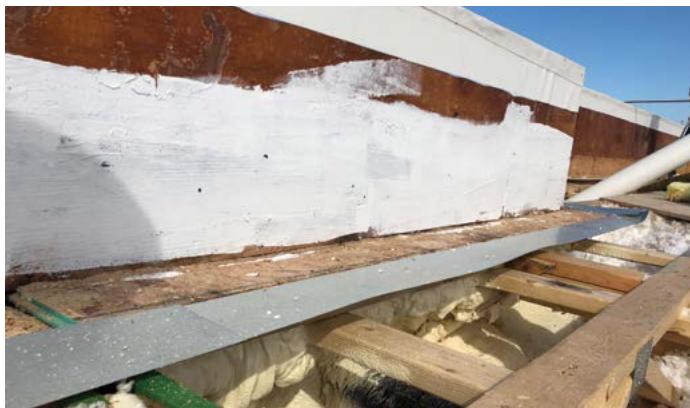
► **Figure 7**

Z-shaped vapor/air barrier transition metal.

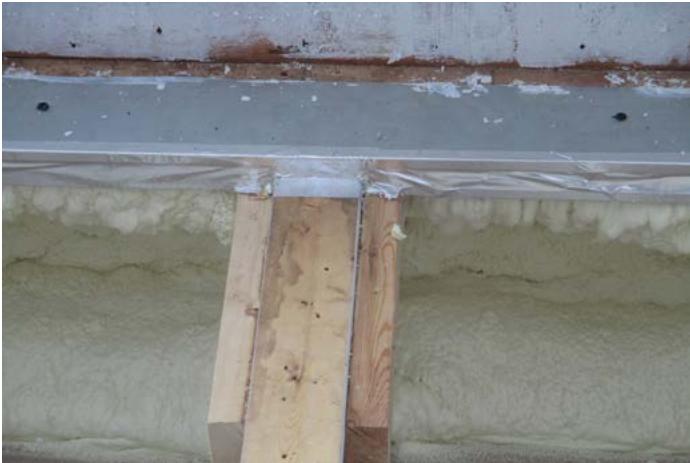
► **Figure 8**

Two-piece U-shaped vapor/air barrier transition metal.

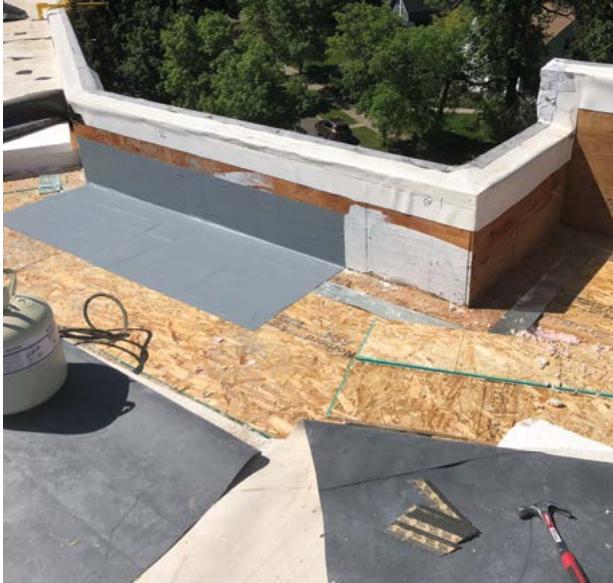
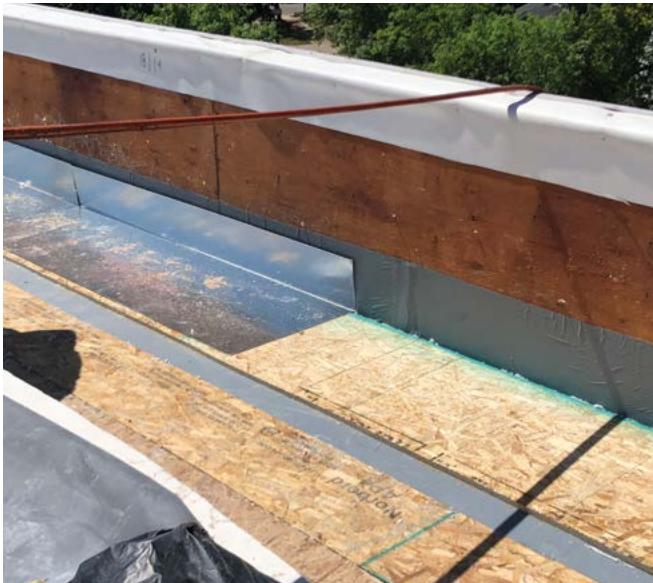
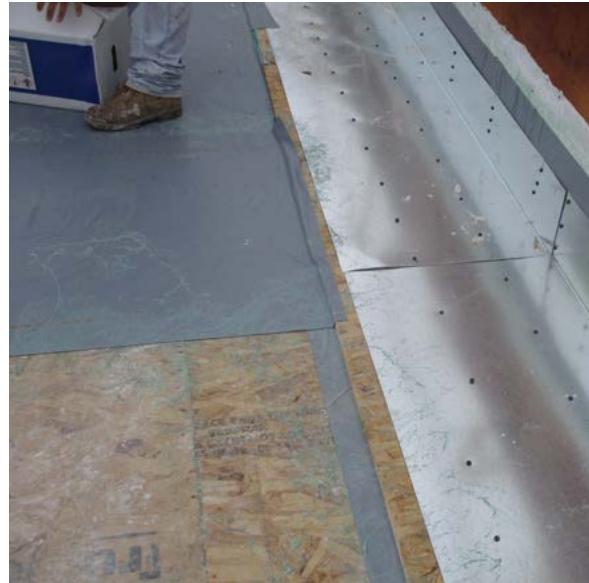
Figure 9

Roof vapor/air barrier at roof perimeter.

Plywood and sheet metal angle parapet reinforcement. Vapor/air barrier applied to field of roof.

A short width of vapor/air barrier was then installed, followed by a parapet reinforcing assembly of plywood and sheet metal angle, and, lastly, the field of the roof vapor/air barrier (Figure 9, page 21).

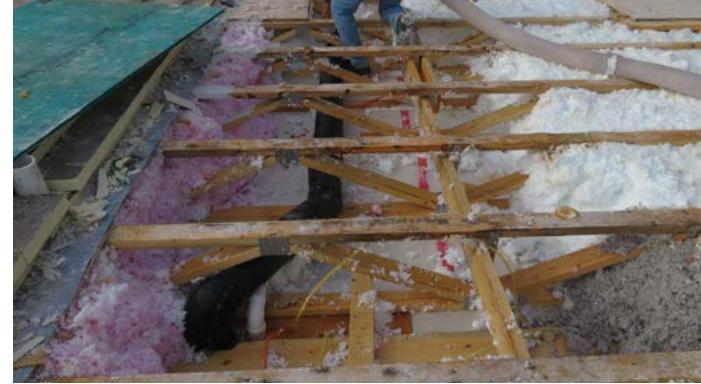
► Figure 10

Blown-in insulation.

The contractor had local insulation and plumbing subcontractors on call to complete varying amounts of work, depending on what was uncovered and anticipated each day. Perimeter work required the presence of the insulation subcontractor to vacuum insulation and install spray foam (in the rim area) and new blown-in insulation (Figure 10, page 22).

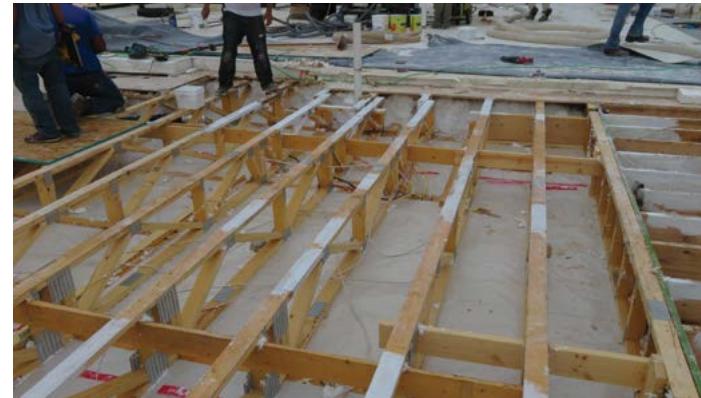
► Figure 11

Mold remediation paint.

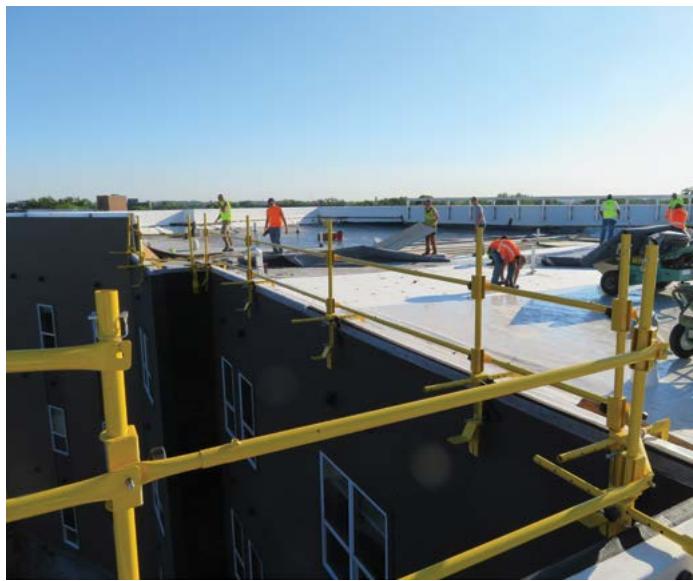
► Figure 12

Perimeter safety rails.

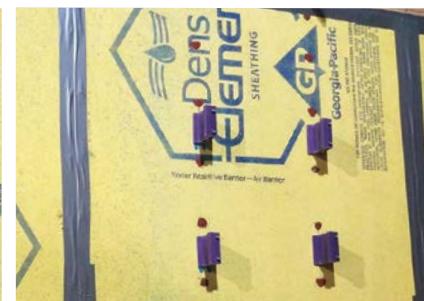
ECO Cladding brackets

For the ECO Cladding aluminum bracket test, the ECO Cladding aluminum anchors were attached to the DensElement Sheathing using two #8 x 1-1/2" screws. Three ECO Cladding Alpha V vertical brackets and three Alpha H horizontal brackets were attached flush to the sheathing. ECO Cladding subframe systems are designed to be installed without the need for additional shimming for drainage.

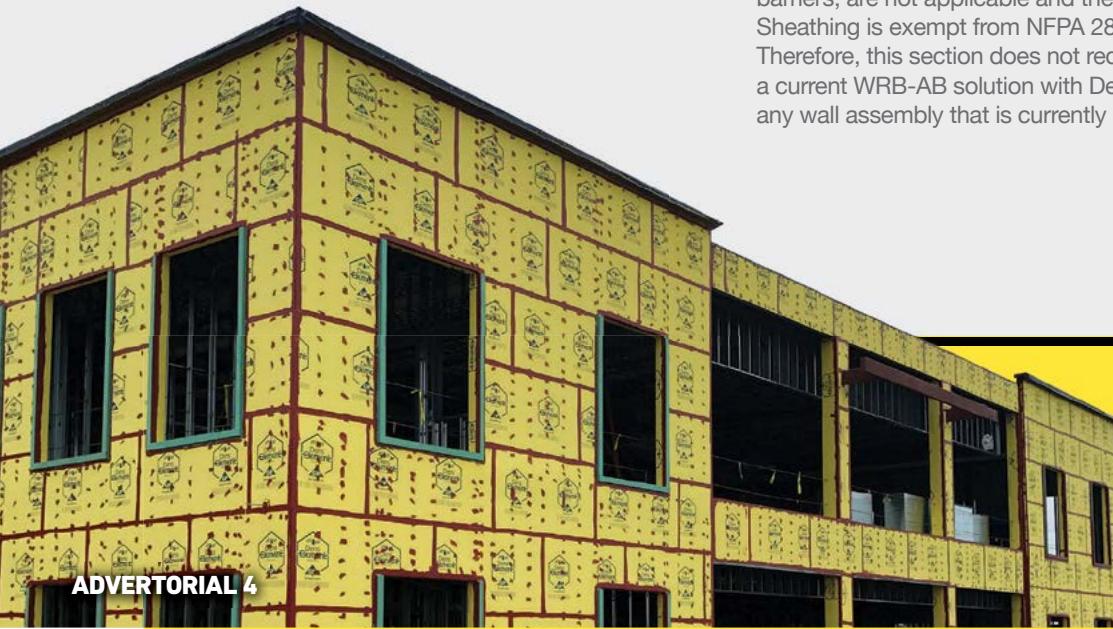
Rainscreen assemblies have grown in popularity for a number of reasons. Providing extra support against potentially damaging weather, rainscreen systems help manage moisture and protect the building's structure from mold and other harmful effects—ultimately reducing maintenance needs.

Unlike in this test situation, actual building scenarios should also include a cladding installed over the subframe, adding to the building envelope's ability to deflect wind-driven rain. In such rainscreen assemblies, the drainage space that these subframes create between the sheathing and cladding helps to promote drainage and further mitigate the risks of bulk water entering the interior side of the wall assembly during a storm.
