# THE construction specifier

solutions for the construction industry | december 2025

# How to Weld to Vintage Structural Steels

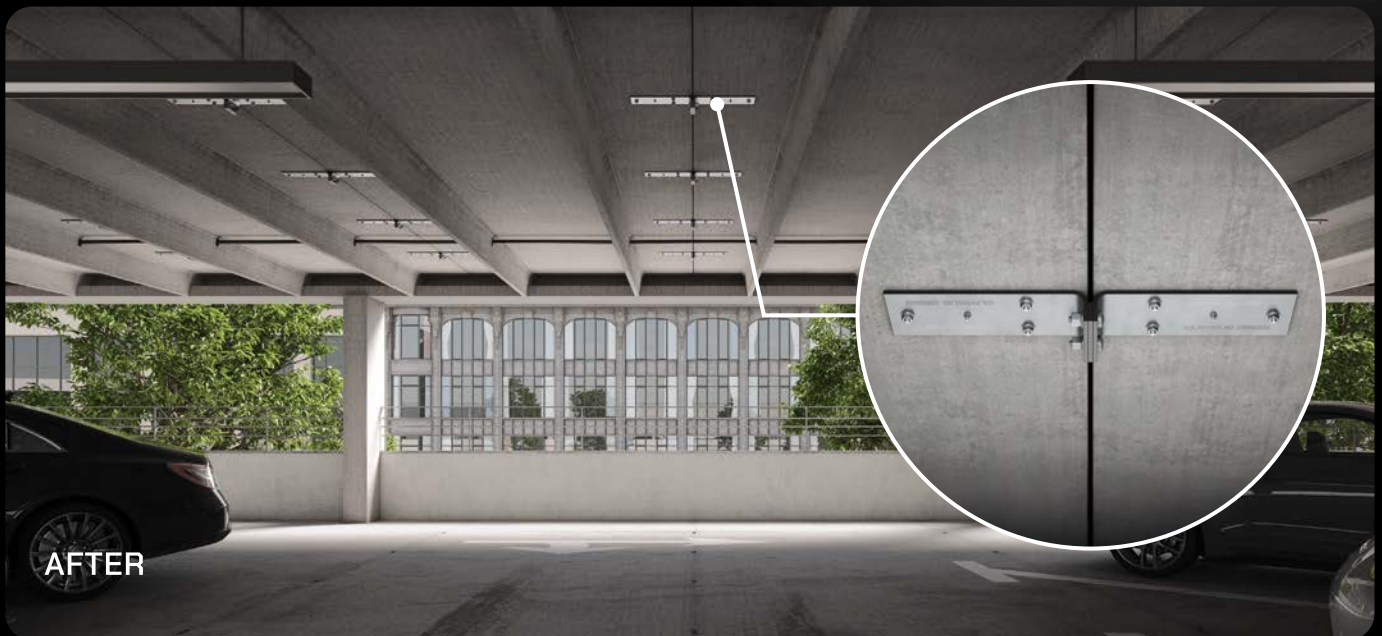
The DTFC is a cutting-edge retrofit solution designed to repair the common connection failures found in precast concrete parking structures. Manufactured from stainless steel, it accommodates thermal and seismic movement, resists corrosion, and installs efficiently without requiring a garage closure. Positioned beneath the parking deck, it links the adjacent tee flanges to restore structural strength and lasting performance.

The result was the Double-Tee Flexible Connection (DTFC), an underside-mounted, stainless steel system designed specifically for retrofit applications. Its flexible geometry allows controlled movement across the joint, relieving tensile stress while maintaining shear integrity.

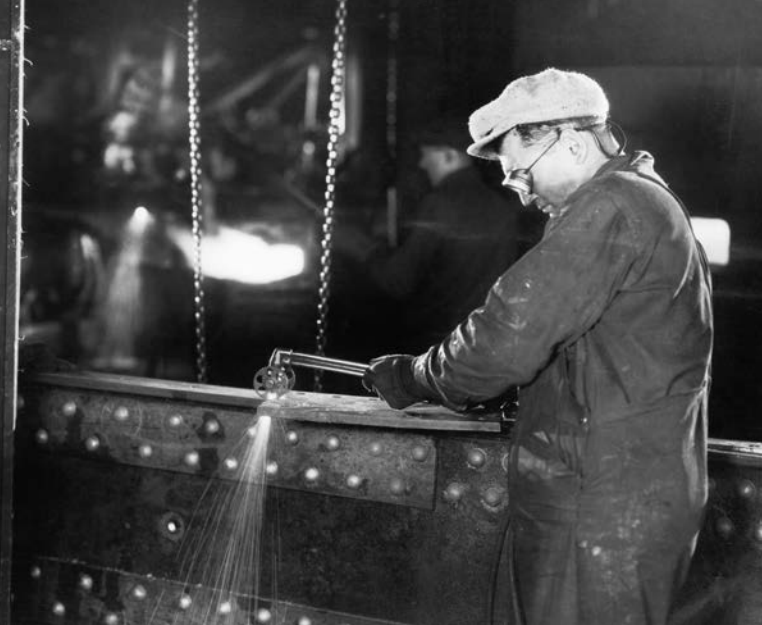
Early welding of structural steel.

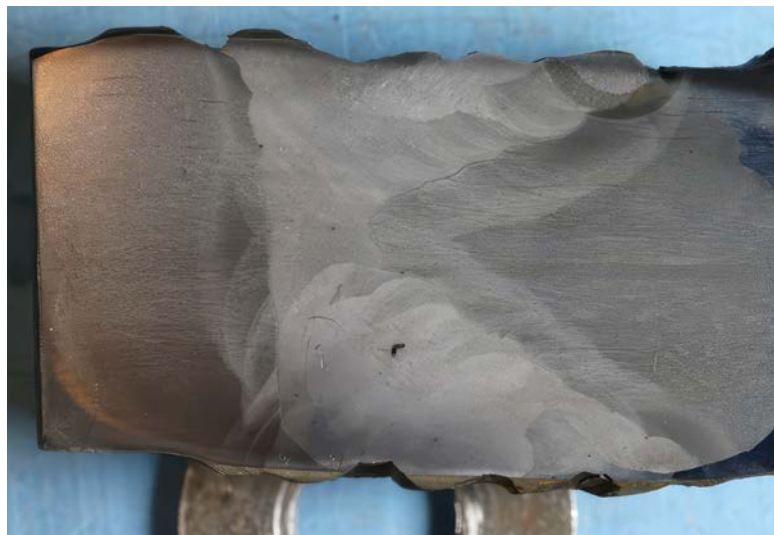
*AWS D1.1* Macroetch Test.

Welding standards such as *AWS D1.1* ensure the weldability of steels using qualification testing of test welds. This involves mechanical testing of the joint using tensile or bend tests, and microstructural assessment (the macroetch test). Testing is required whenever the material, geometry,

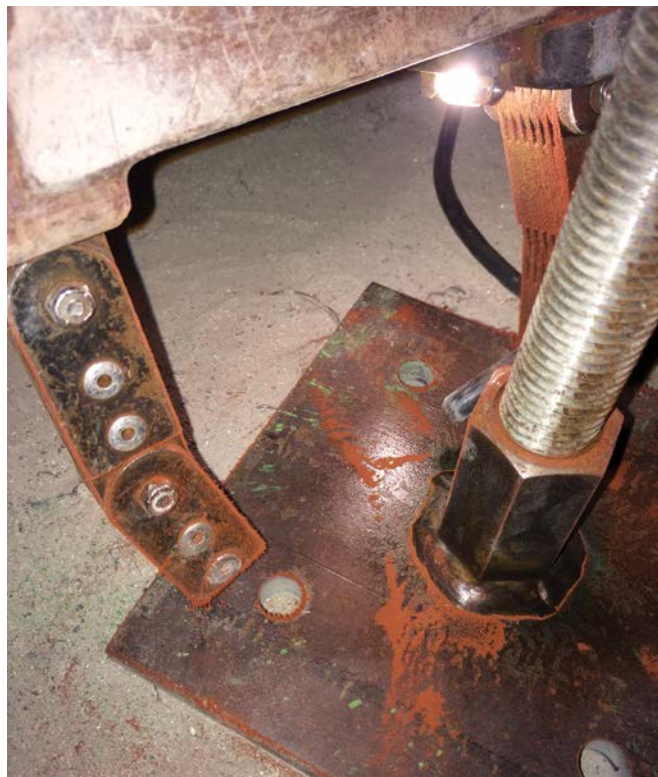
Magnetic particle inspection of welded joint.

welding, 100 percent inspection of the weld metal is preferred to search for hot tears. As these cracks can form under the surface of the weld metal, non-destructive examination (NDE) techniques such as magnetic particle (MT) inspection or ultrasonic (UT) are preferred, if the weld geometry allows this technique to be employed.

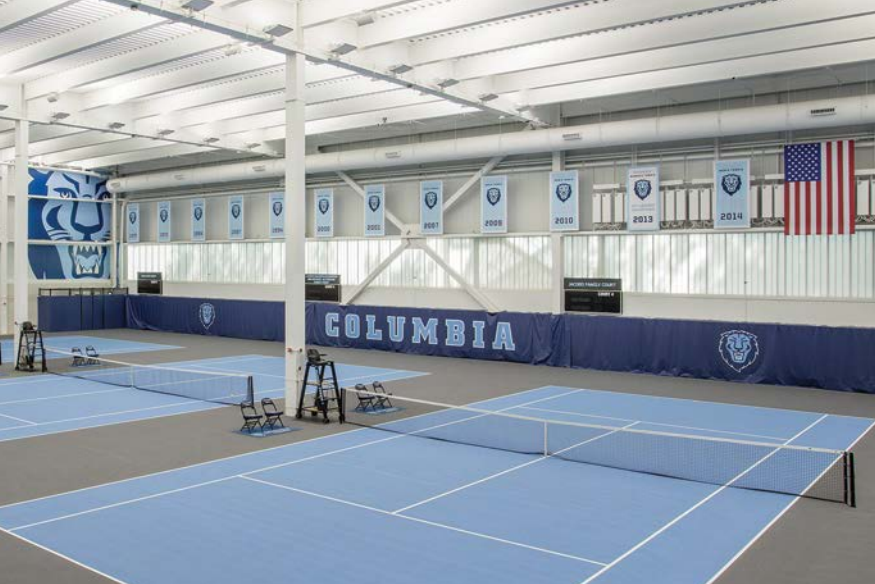
The Philip & Cheryl Milstein Family Tennis Center stacks 12 National Collegiate Athletic Association (NCAA) compliant courts on a compact Manhattan footprint, maximizing space efficiency in the nation's most densely populated county.

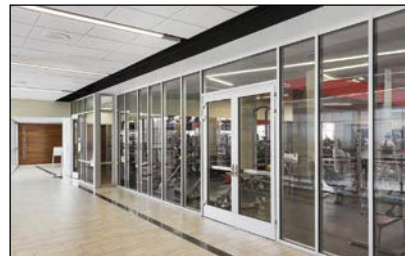
Aluflam North America, a leader in fire-rated aluminum/glass construction, announces a significant advancement in their true aluminum framing system. Utilizing Vetrotech's groundbreaking CONTRAFLAM® One interlayer technology, Aluflam can now provide improved performance in a single intumescent chamber solution across all performance ratings.

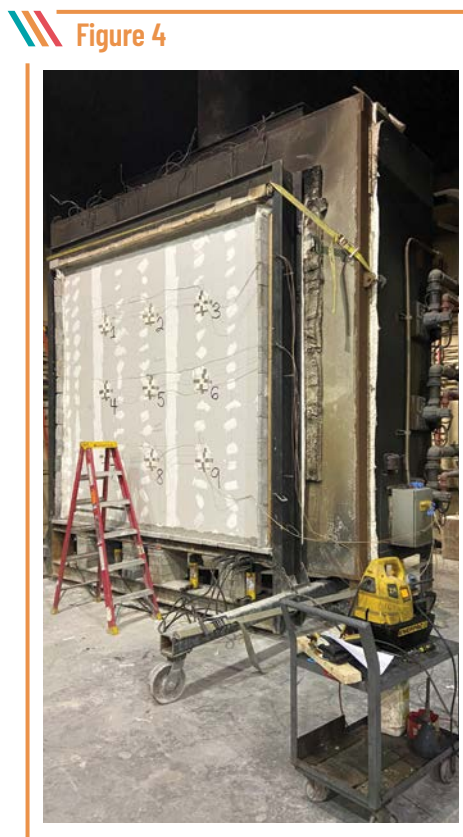
**Figure 4:** Wall  
assembly subject  
to ASTM E119  
fire test.

It is also necessary to evaluate the ability of an exterior wall assembly to resist fire penetration from exterior fire exposure. In California, this evaluation can be conducted

using the test described in the *State Fire Marshal (SFM) Standard 12-7A-1*,<sup>24</sup> which is mandated in jurisdictions referencing Chapter 7A. This test specifically addresses direct flame penetration through residential exterior wall assemblies in WUI areas. However, it does not consider flame propagation along the exterior wall into attics through eaves, or the subsequent risk of spreading to the building's interior by these paths. For this reason, using noncombustible materials in the exterior building envelope is highly beneficial, as it significantly improves a structure's resistance to both flame propagation along, and flame penetration through exterior wall and roof coverings.

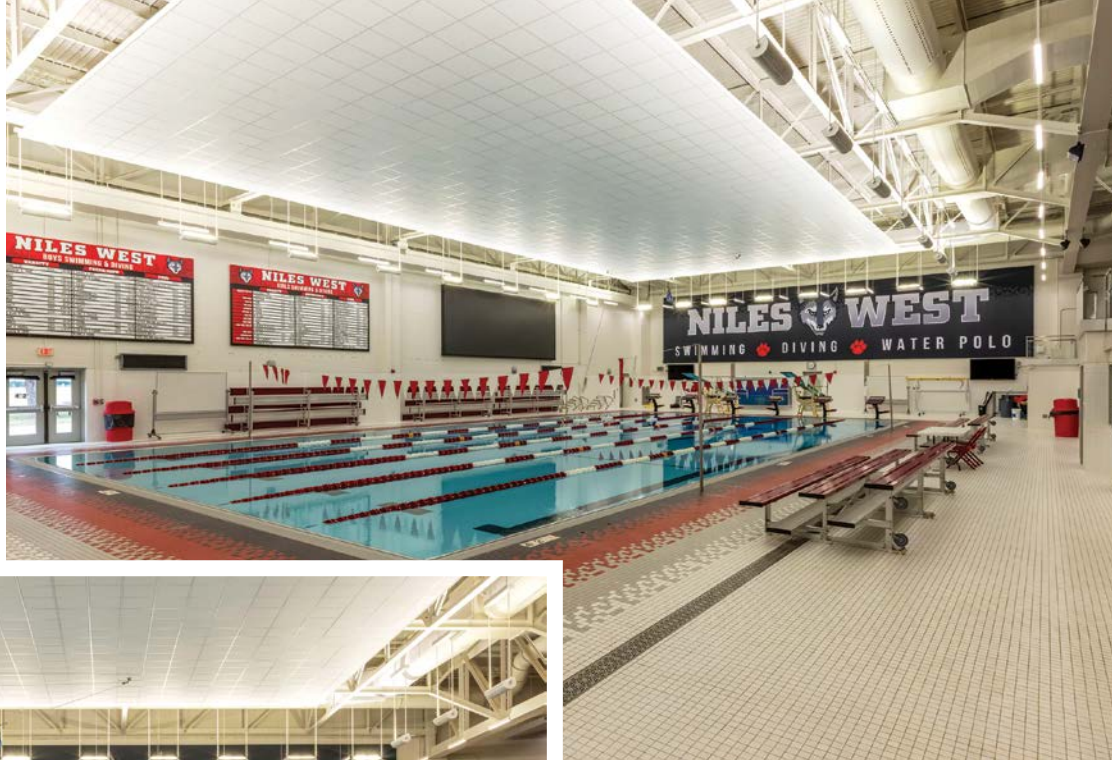
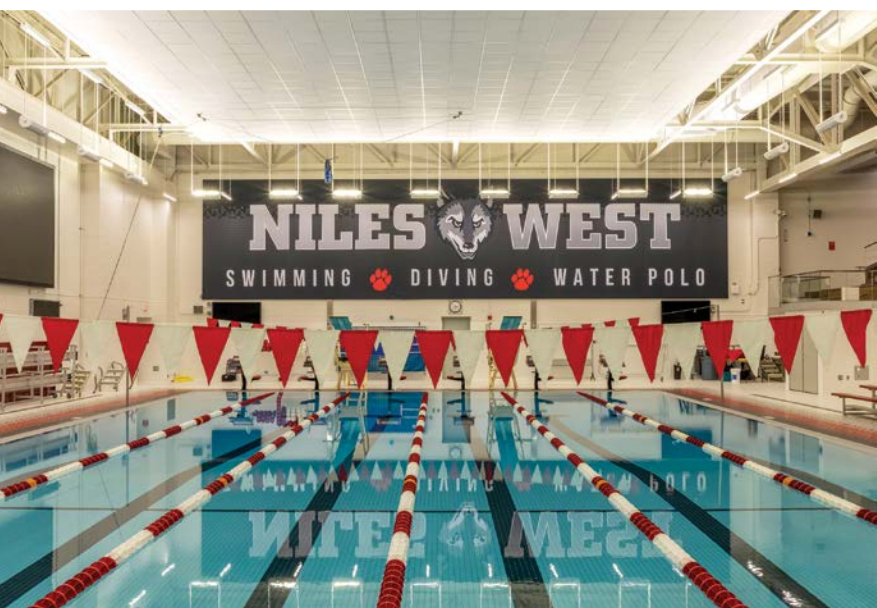
The use of indirect illumination above the pool's perimeter reflects off the dropped ceiling to reduce glare and veiling reflections, and improve the clarity of underwater viewing and related safety.

The new LED pendant luminaires located on the perimeter of the pool are a dramatic improvement over the previous metal halide fixtures—they strike instantly, provide far more lumens, will last for years, and are cost effective.
