the construction  
**specifier**

**Best of Series**

**BUILDING WITH  
MASONRY  
ASSEMBLIES**

# Understanding Challenges with Adhered Masonry Veneer

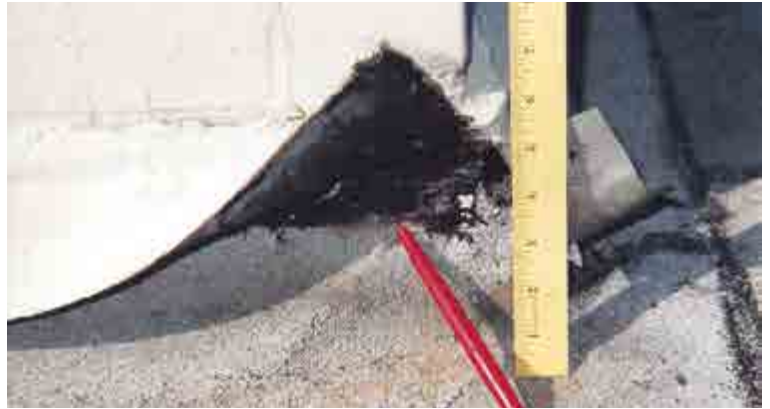
In this project, lifting back the improperly installed sheet metal counterflashing reveals the height of the base flashings are improperly installed and terminated less than 200 mm (4 in.) higher than the finished roof surface.

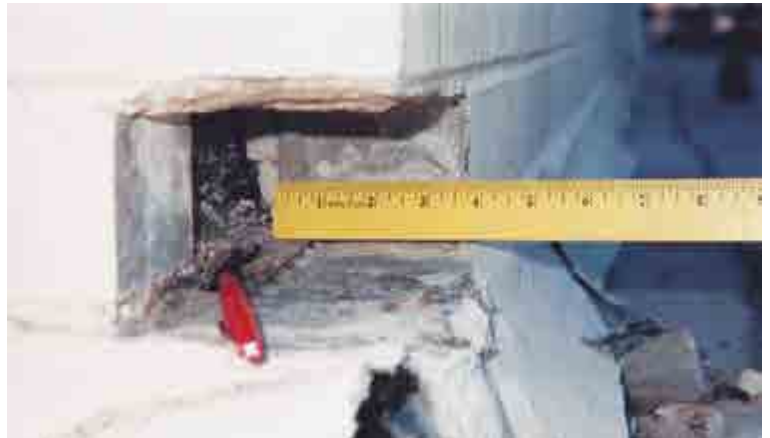
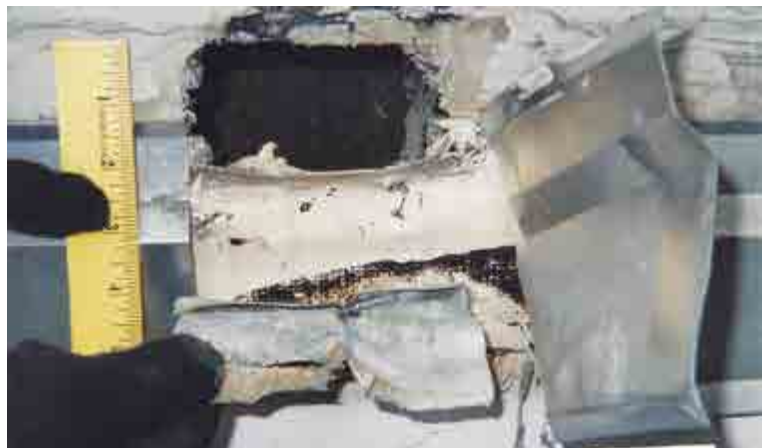
The two photos above provide close-up views of an improperly installed and deteriorated sheet metal through-wall flashing assembly. Inadequately installed sheet metal and surface-mounted counterflashing can be seen.

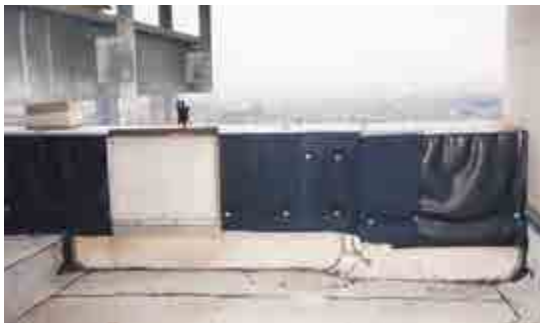
The photo above shows an unsuccessful attempt at controlling the leak via the use of a black polypropylene sheet mechanically fastened to the inside face of the outer perimeter masonry parapet wall.

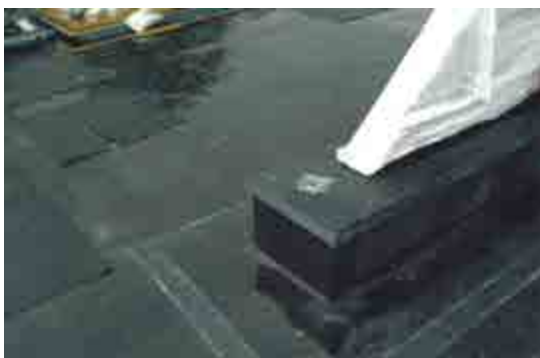
An example of a properly installed through-wall flashing assembly. The 400-mm (8-in.) minimum height requirement of the base flashing has been met.

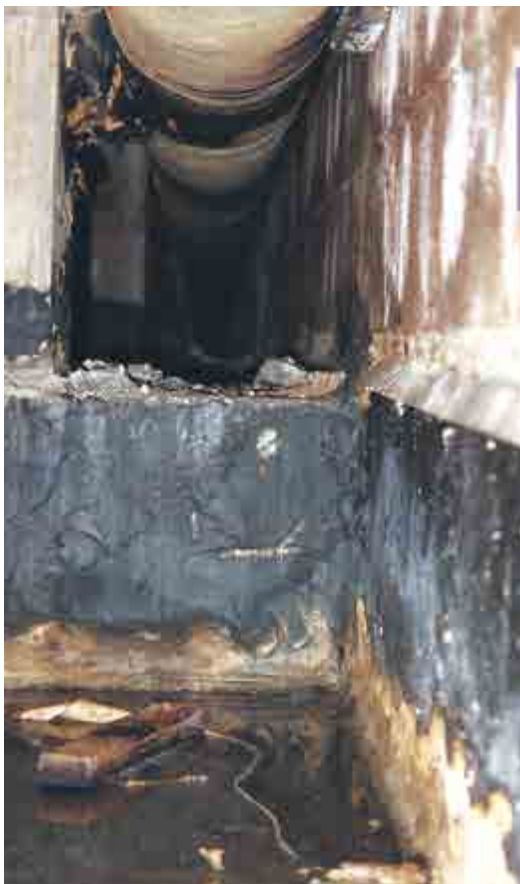
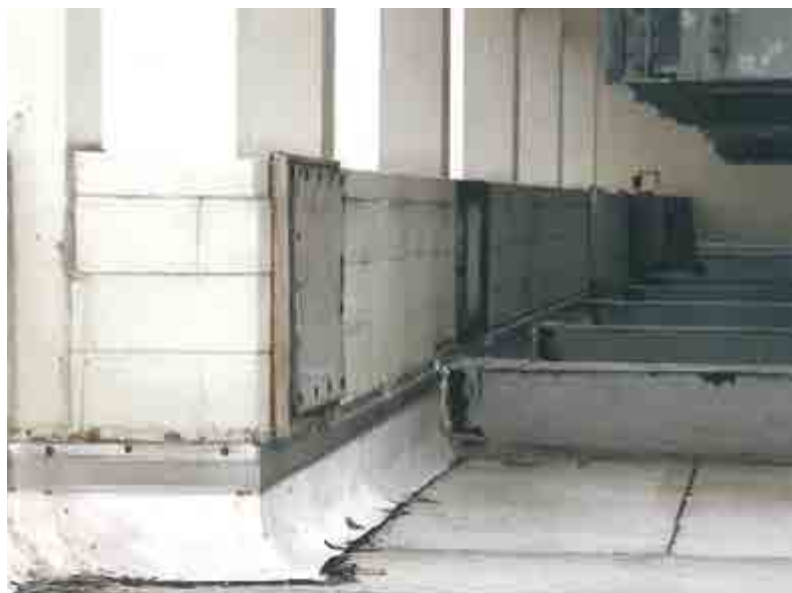
Deteriorated mortar joints on the outside wall pipe chase. (The access panels were built into the pipe chase structure.) The photo on the right shows inside the chase—note the the standing water at the bottom of the photo, along with the efflorescence on the exterior portion of the outside parapet wall.

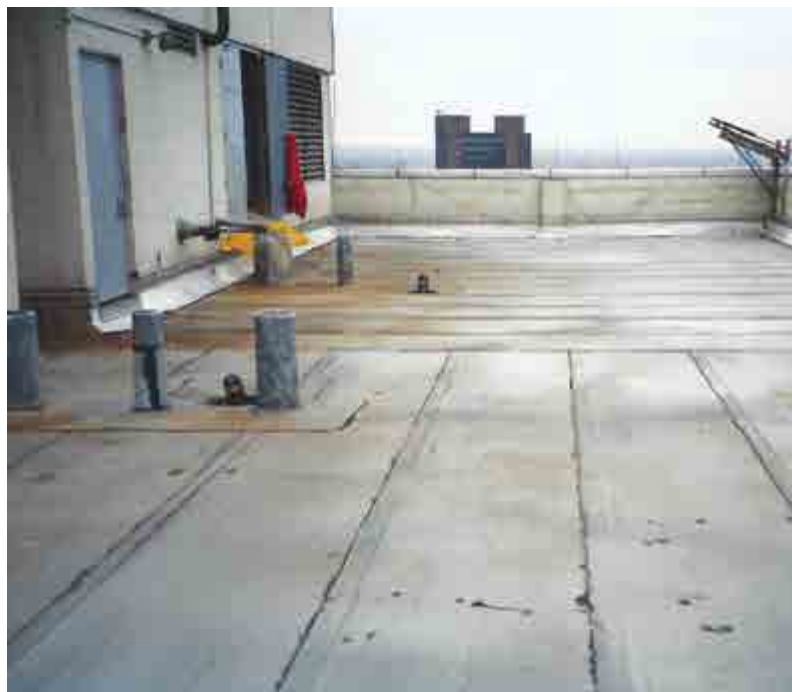
The installation calls for all lapped seams to be horizontal, and taped using the tape manufactured specifically by the WRB producer. The water-resistive barrier gets fitted to the contour of all exposed areas of the rising/parapet wall sheathing. This material is then fastened with the approved fasteners following fastener density protocol. The drainage plane system then gets installed, covering all exposed areas of the WRB.

Note the condition of the concrete masonry unit (CMU) mortar joints, along with the dissimilar base flashing materials at the base of the outer perimeter parapet wall.

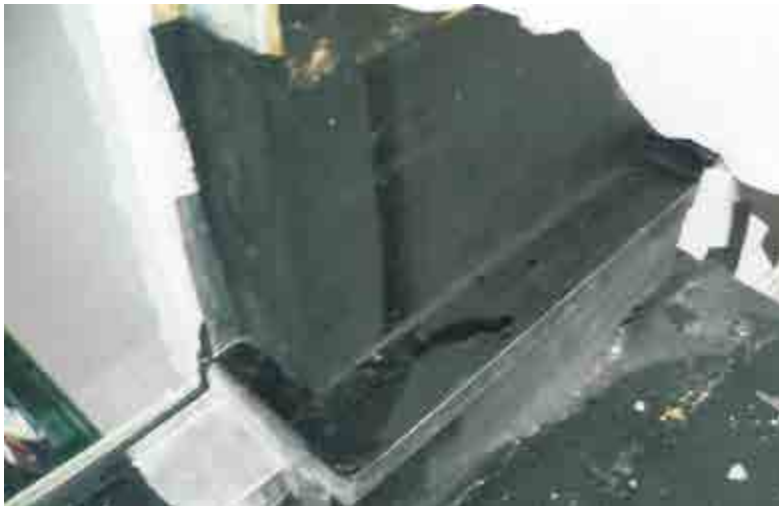
A close-up view of a properly installed through-wall flashing assembly. There is lead-coated copper sheet metal flashing covering over, and soldered above, a field condition at the left-hand portion of the assembly. Additionally, note the end dam at the upper right-hand portion of the photograph.

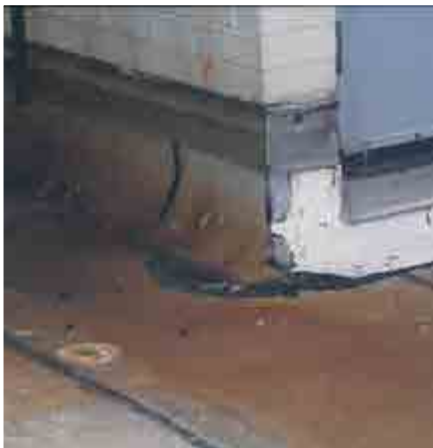
Southeast corner of the mechanical room elevation structure. Note the dissimilar materials added to the bottom and the surface-mounted counterflashing at the base of the door threshold. In the close-up at right, the counterflashing has been taken apart; the original sheet metal through-wall flashing is buried in the wall behind the new base flashing material.

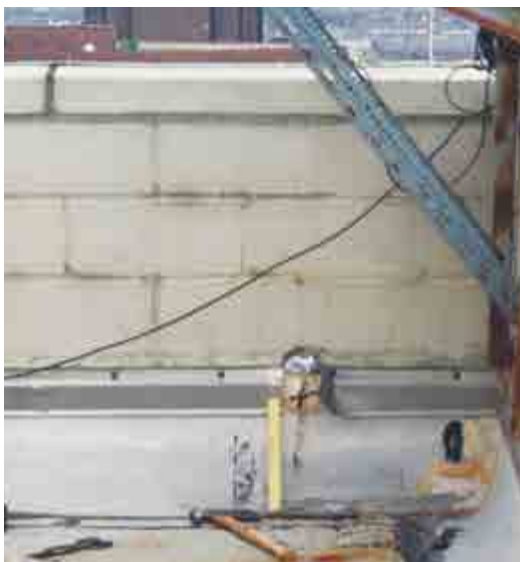
The approach taken to eliminate the leakage on this project involved removing all existing brickwork necessary to properly install a new EPDM-clad sheet metal through-wall flashing at the interface flashing transition area.

This approach required the physical removal of the brickwork to gain access to the existing improperly installed sheet metal through-wall counter flashings. It also included the removal of all brickwork around the entire outer perimeter walls on the main building, and at all interior perimeter walls of stair tower elevation structures.

Additionally, the entire roof was removed and replaced, this time utilizing the new through-wall flashings. On completion of the replacement roof system, the previous leaking condition was successfully eliminated.

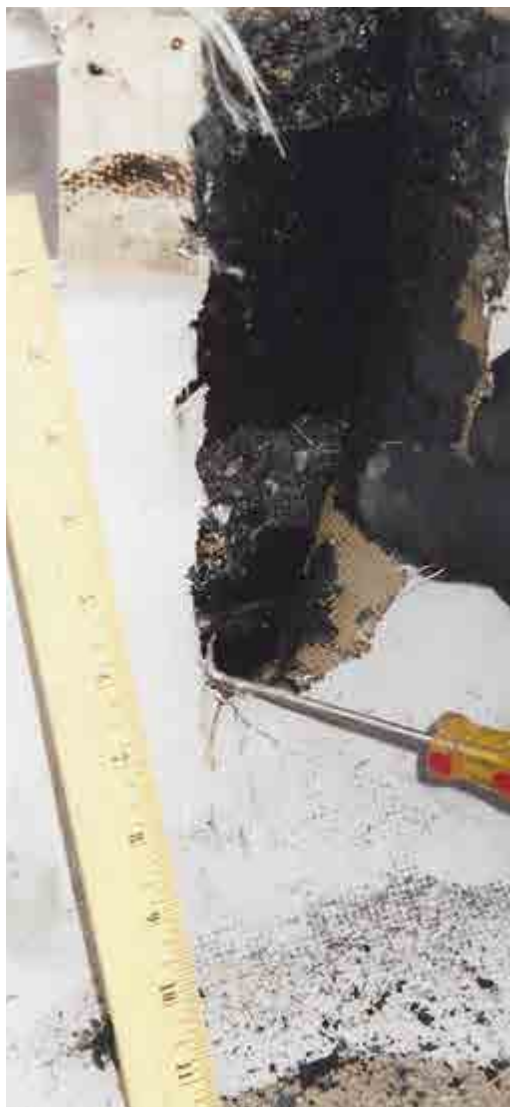
Close-up view of the interior side of the CMU parapet wall. Note the base flashings installed over the original through-wall flashing and the condition of the mortar joints. At right, one can see the top of the probe is touching the original sheet metal through-wall flashing. Also, note the original through-wall is buried in the wall behind the outermost base flashing material.

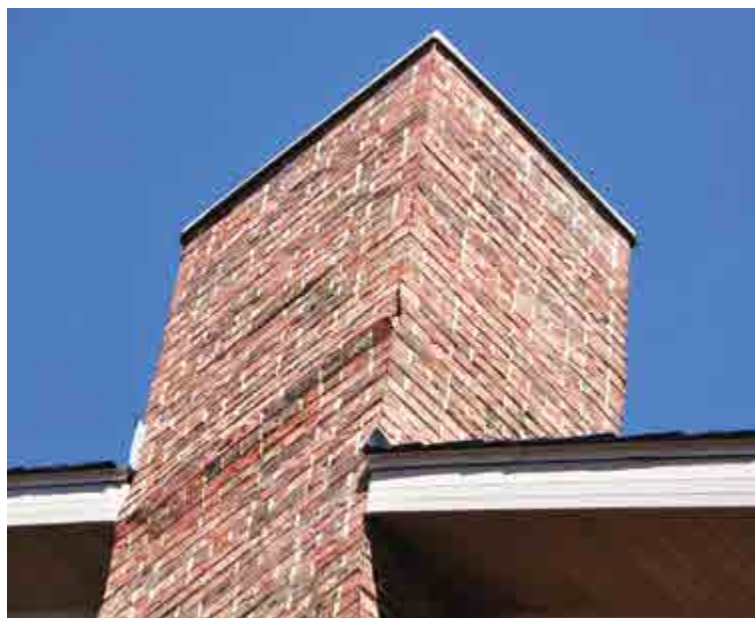
► Figure 4

The above photo shows adhered clay brick that is cracking and debonding due to failure to accommodate vertical shrinkage of the wood structure, coupled with poor moisture control details on this four-story chimney.

In the early years of the adhered masonry veneer market, these thin wallcoverings were primarily used for small-scale wainscot or other exterior accents on residential building types, or for interior elements such as fireplace surrounds or feature walls. Today, the adhered masonry veneer market has expanded to include whole building elevations on multi-story commercial facilities and other large buildings with increased exposure, greater loads, complex design, and high serviceability expectations. When using adhered masonry veneer systems on large-scale projects, it is critical to accommodate material and differential movement in both horizontal and vertical directions (Figure 4).

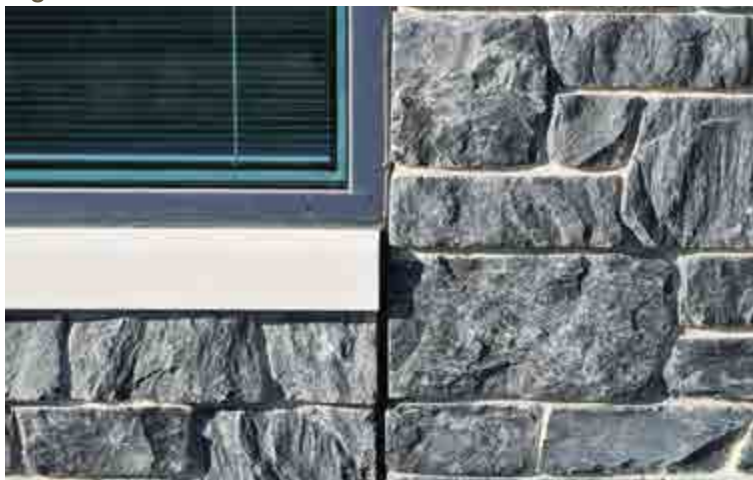
► **Figure 5**

The 9.5-mm (3/8-in.) gap at all sides of window and vertical movement joint in the adhered cladding is aligned with the window jamb.

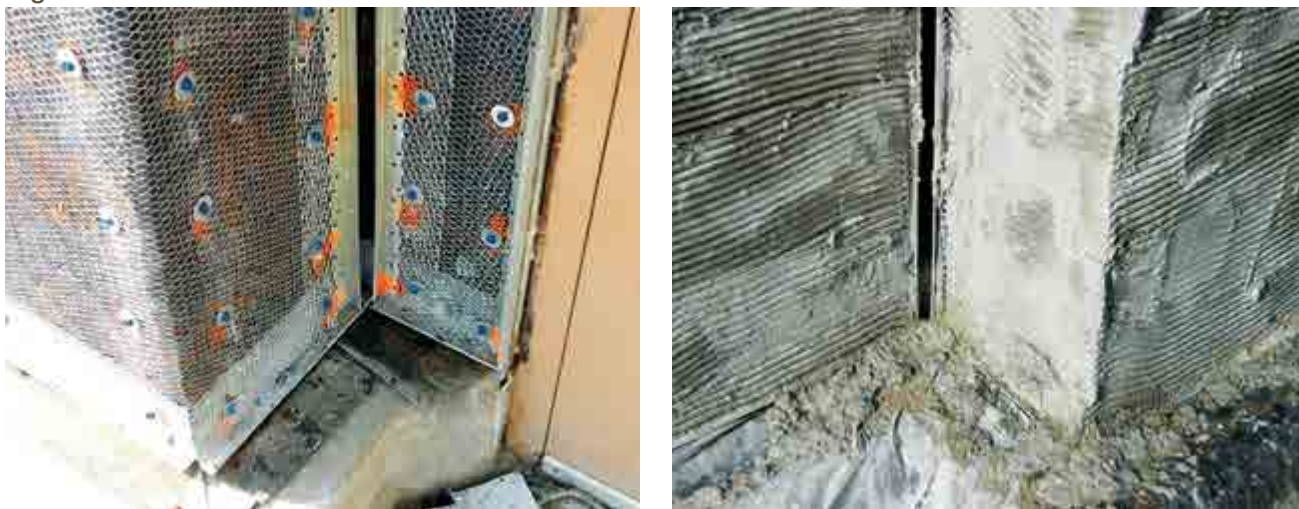
► **Figure 6**

Vertical movement joint prep at interior corner (left). Cladding at interior corner, with polymer-modified scratch coat (right).

Movement joints in adhered masonry veneers are formed by using corrosion-resistant casing beads so the joint extends at least through the mortar setting bed, scratch coat, and metal lath (Figure 6). In most scenarios, the respective aligned movement joint in the support wall is made watertight/airtight with an adhesive transition strip. If there is a flexible drainage mat as part of the detail, it can be continuous through the movement joint.

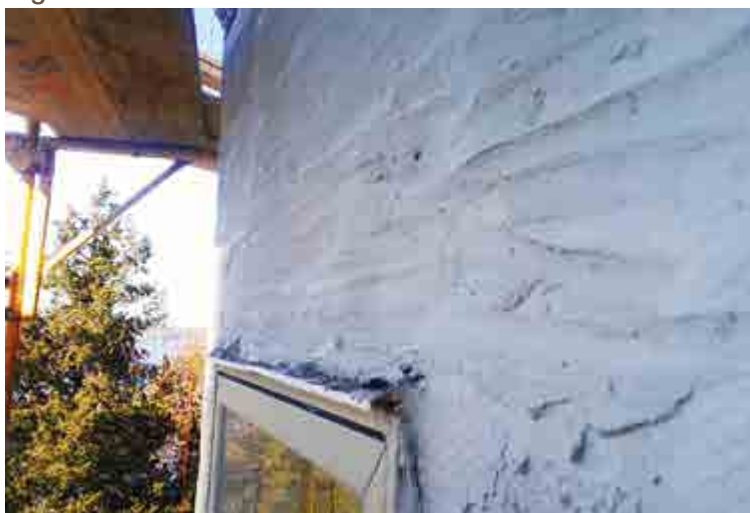
► Figure 9

sheets and form an obstruction to the downward flow of moisture and the movement of air. To complete the drainage wall concept, a moisture and air barrier, corrosion-resistant flashing (especially above openings and at top-of-wall details), and weep screeds should be installed before the drainage mat (Figure 9).

Flashing and weep vents installed above a window. This wall has an adhesive water-resistive barrier (WRB), drainage mat with filter fabric, metal lath, and scratch coat.

Drainage mat sheets should be installed tight to one another, with filter fabric lapped, so the mortar scratch coat cannot squeeze between the

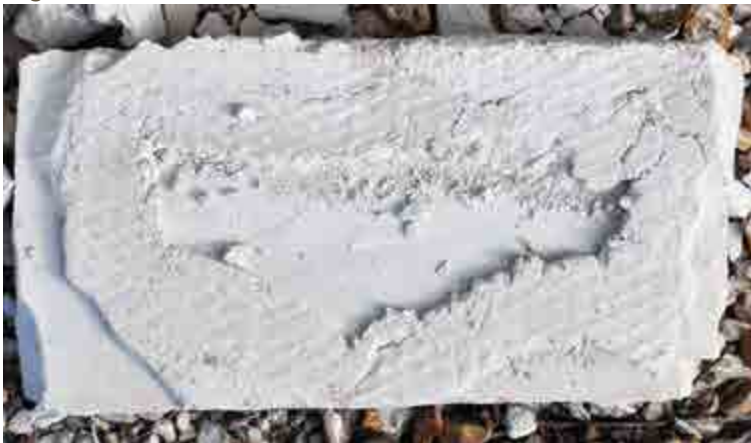
Figure 10

An example of unacceptable mortar-setting material coverage. At least 95 percent of the stone should be covered with mortar.

- specifying durable cladding products that can withstand exposure at unit edges;
- inspecting the installation process for complete mortar coverage on the back of veneer units so moisture cannot congregate behind the cladding (Figure 10); and
- instructing the masons to install extra setting material around the perimeter of the veneer units so mortar can squeeze out between them (Figure 11, page 21).

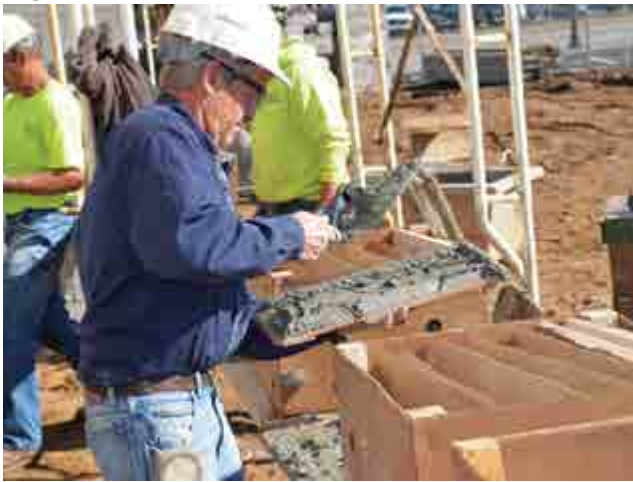
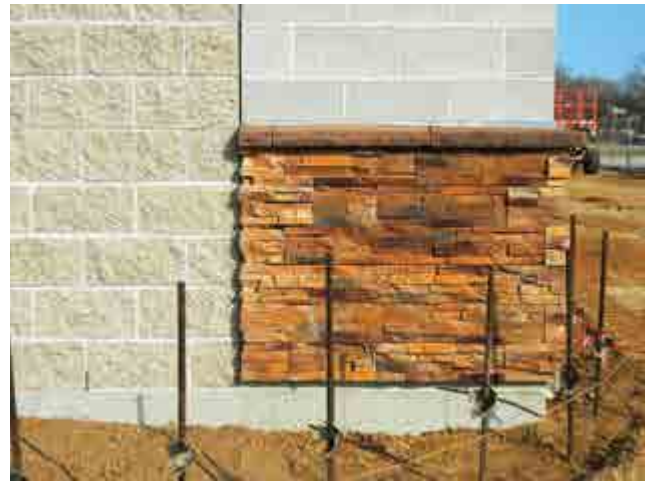
Figure 11

A skilled mason applies ample polymer-modified mortar to the back of a thin stone panel for a durable dry-stack veneer installation. Split-faced CMU, dry-stack thin stone, and exterior insulation and finish systems (EIFS) combine for a loadbearing masonry retail project.

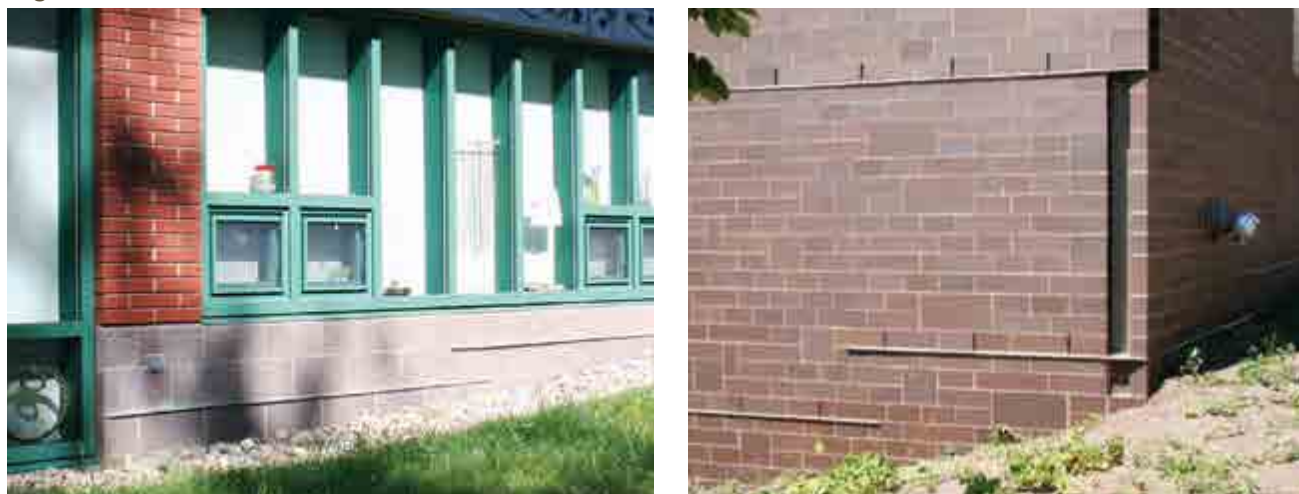
However, drip-edge flashing at highly visible building locations can create aesthetic concerns, as shown in Figure 1 (page 25).

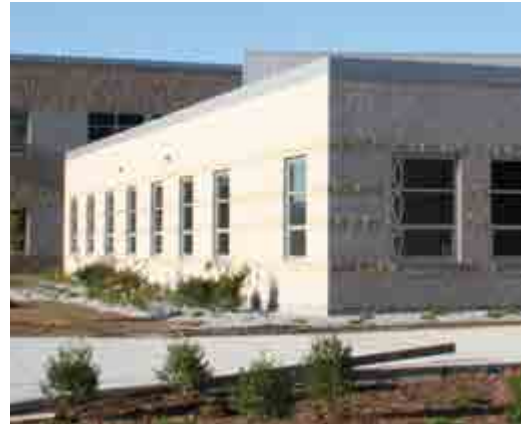
Figure 3

A concrete shelf above grade provides optimal protection of the masonry veneer and wall system. Landscaping can hide the concrete if desired.

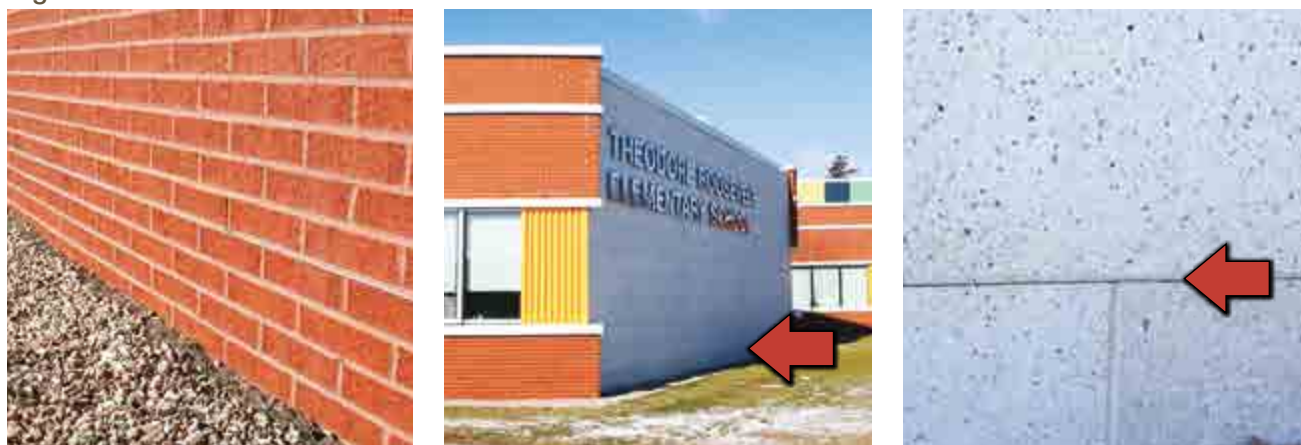
► Figure 5

Successful results with flush hemmed-edge flashing at Theodore Roosevelt.

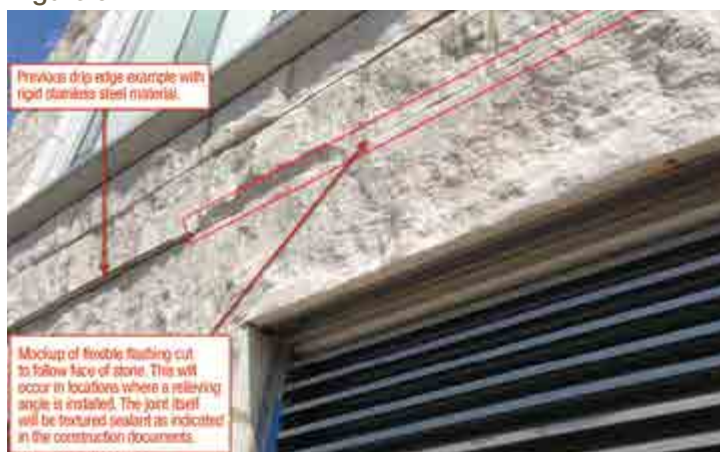
► Figure 6

New stainless steel membrane adhesive flashings can be cut after they have been installed to follow the contour of the stone veneers.

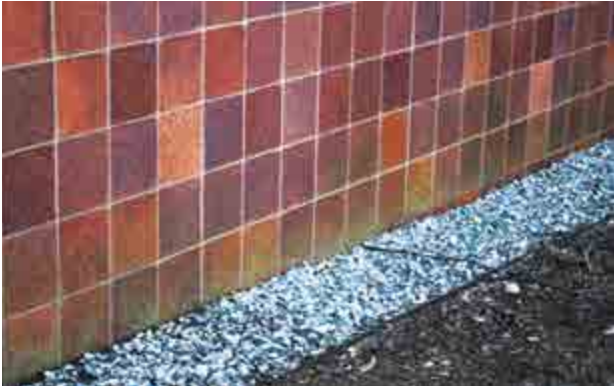
Figure 9

In the photo above, mowing strip and drainage material protect the brick. High-strength, dense masonry units provide superior protection below grade in this case.

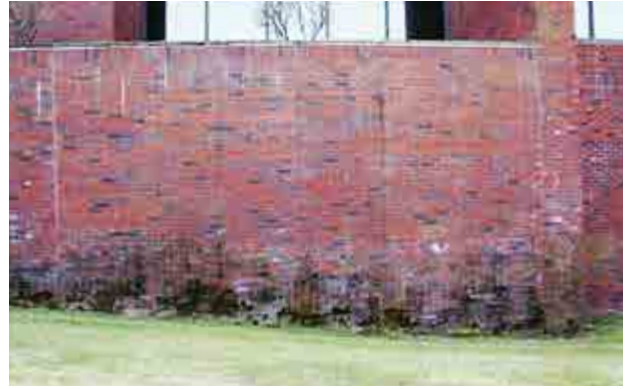
Figure 10

Brick staining near grade. Possible culprits include no mowing strip or drainage material, lack of drip edge, softer (and more absorptive) brick improperly maintained, and irrigation hitting the building.

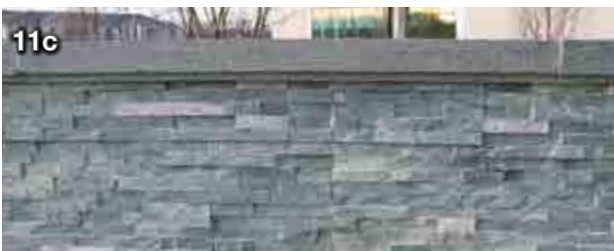
Figure 11

Top of wall: detail of a stone cap with overhang.

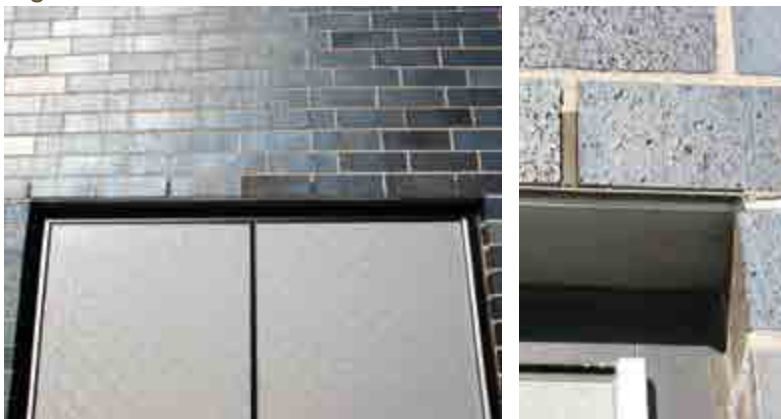
Figure 14

Drip-edge flashing above a door protects the steel lintel and diverts water away from the sealant joint at the doorframe.

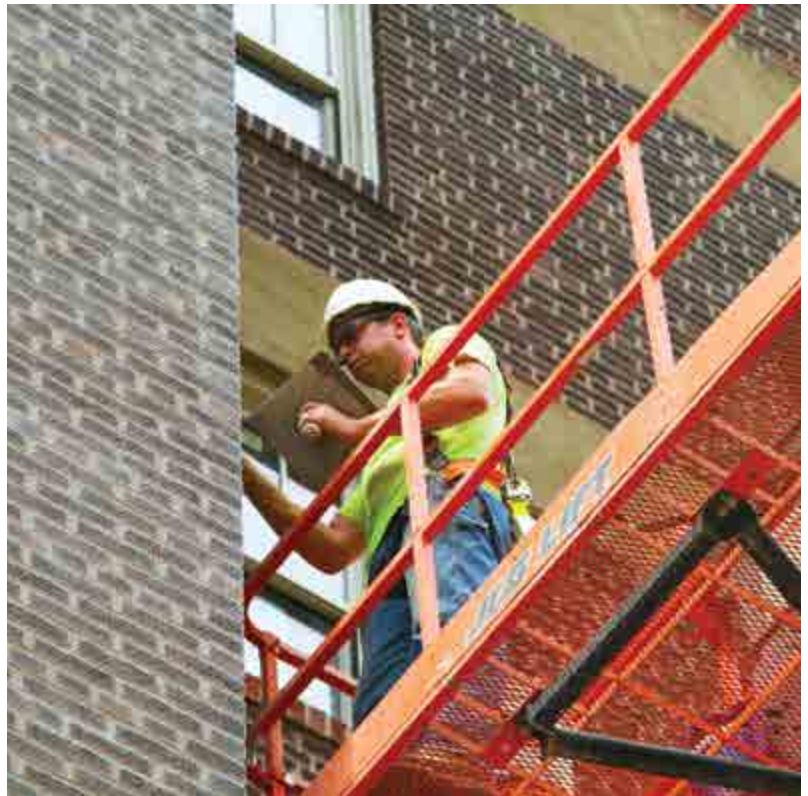
Mockup samples were created to give the general contractor and historical consultant a visual reference for selecting a mortar color and seeing how the joint profile would look. This process also helped give an idea of where in the building the mortar mockups should take place.

Different colors were applied and reviewed in different lighting.

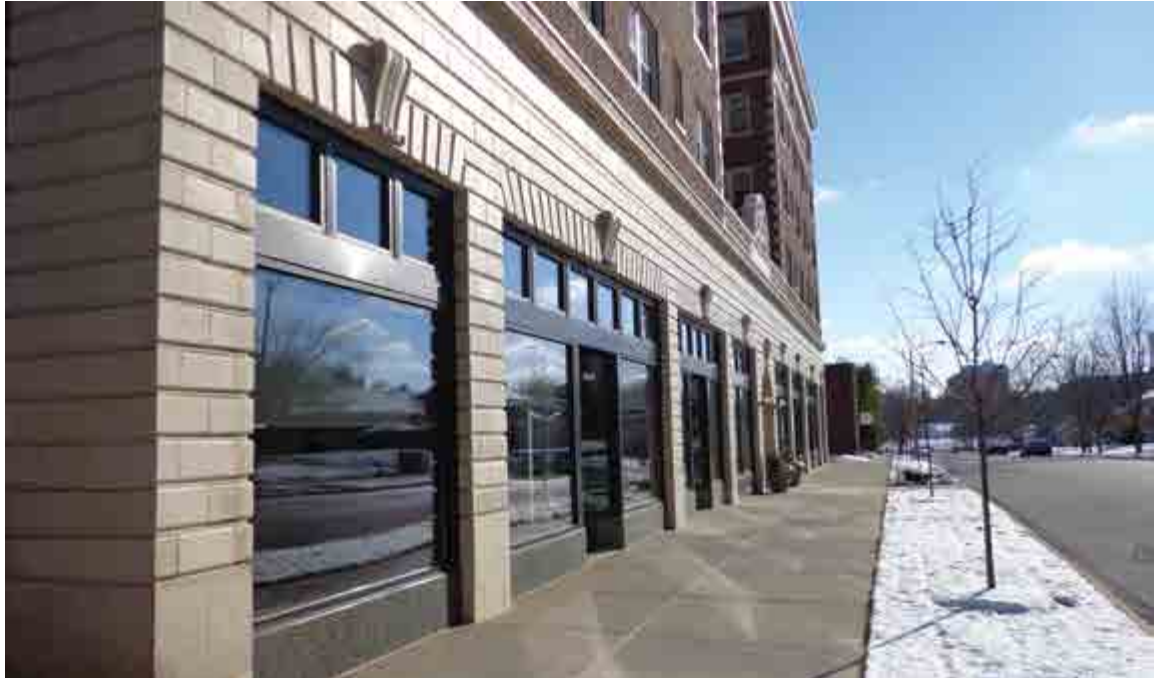
Before tuck-pointing could begin on the brick, crews had to examine existing building joints, which were frequently different due to the building's multiple repairs over the years.

Before tuckpointing could begin on the brick, existing building joints had to be examined. Different types of joints had been used during the building's lifespan due to the need for multiple repairs. Therefore, it was difficult for the team to determine which joint profile had been used when the structure was originally built. A concave profile for the tuck-pointing provided the best design for shedding water away from the masonry walls.

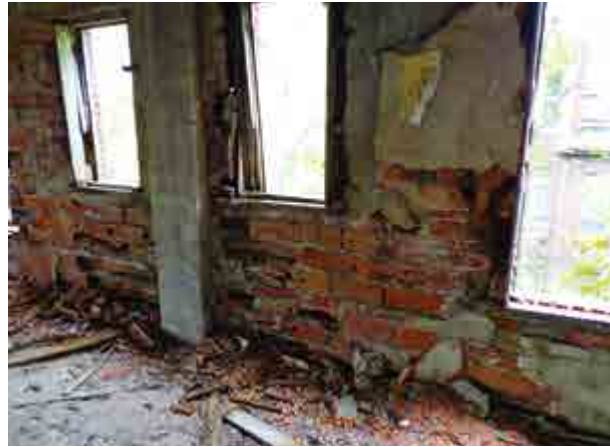
The work included restoring crumbling interior masonry walls. Broken windows throughout the building and missing copper downspouts had exposed the walls to the elements, causing major damage and instability.

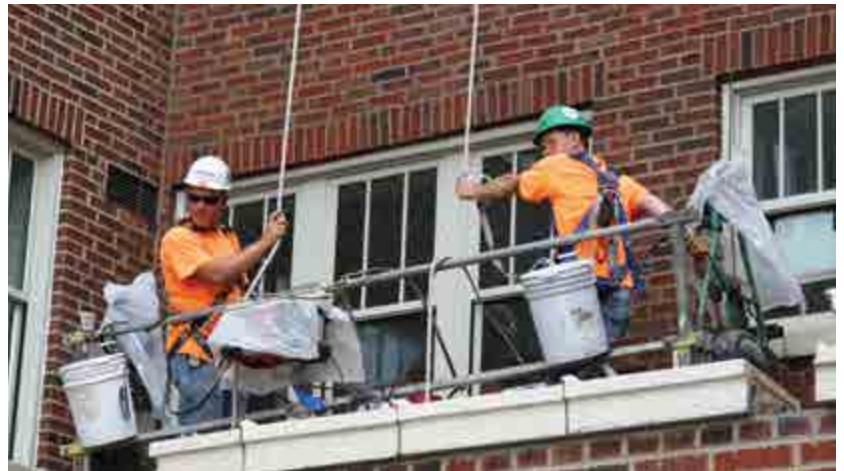
After completing the interior masonry work, the façade was the next step. A complete visual inspection and sounding of each wall was completed to determine which bricks on the building's façade needed replacement.
